**INSPECTION OF ELECTRICAL INSTALLATION
FOR LINDO MAR RESORT – JACUZZI**

CLIENT: LIC. ROBERTO CHAVEZ
LOCATION: PUERTO VALLARTA, JAL.
DATE: FEBRUARY 19, 2021

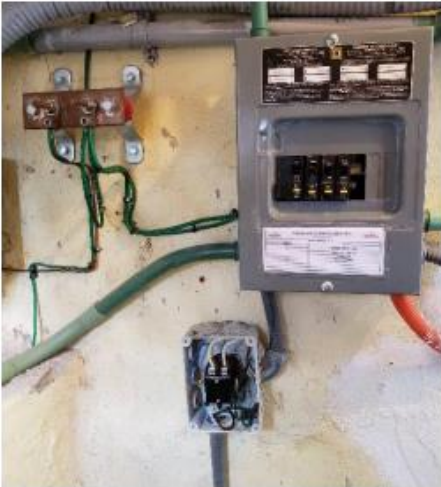
2.1.1. GENERAL LOAD CENTER

(V) L1-N =	121.0
(V) L2-N =	127.0
(V) L1-L2 =	215.0

(A)L1 =	7.7
(A)L2 =	16.8

It has a QO816L100F load center with four thermomagnetic switches with grounding fault detection. Three of these switches are 15A and one is 20A. The load center is supplied by caliber 8 AW6 conductors, the grounding system utilizes the same caliber conductor.

- All switches are thermomagnetic with grounding fault detection of the same ampacity. (Section 680-40)
- There is a copper rod to ensure that the grounding fault system itself is duly grounded. (Section 680-6)
- There is a directory of circuits on the panel. Each circuit is legible indicating its purpose or specific use, evident and clear (Section 408-4 a).

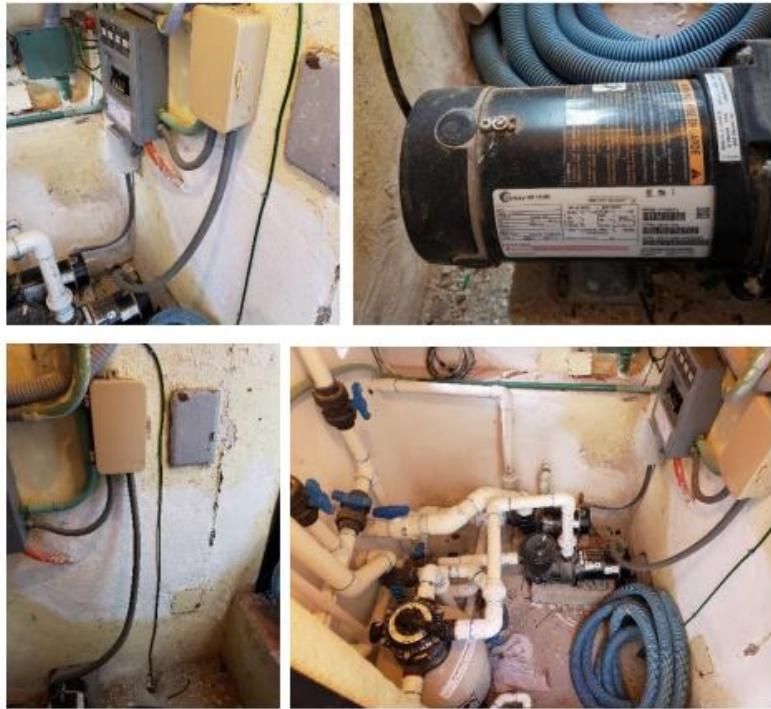
2.1.2. EQUIPMENT

2 Pumps of 1 HP are installed to supply the jacuzzi. It also has 2 luminaires for the jacuzzi and one contact.

- The motors have liquid tight flexible pipes for each one of them, this ensures greater safety on the installation (Section 680-21a)
- The motors are duly connected to the grounding fault system (Section 680-21)

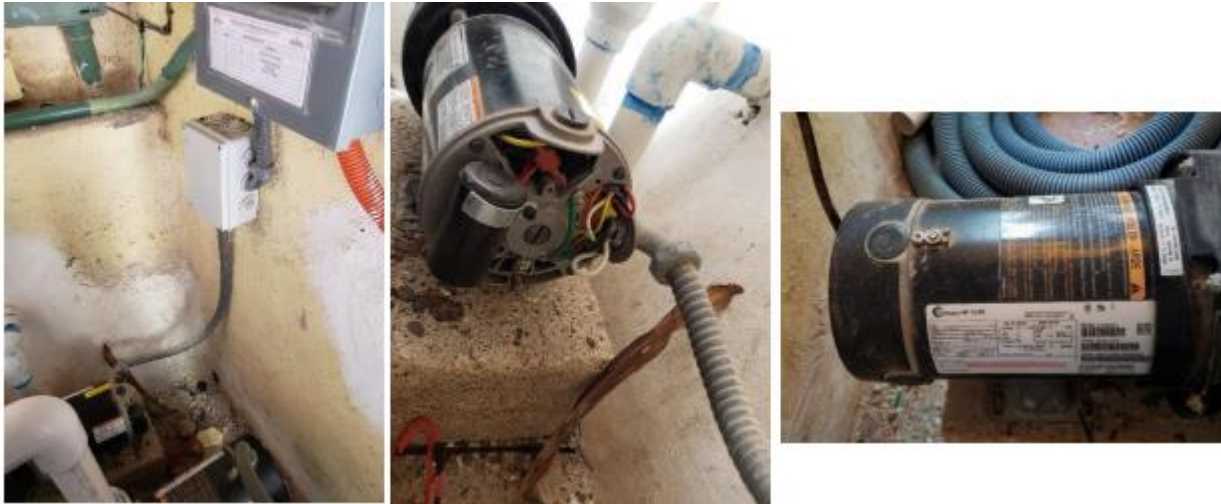
2.1.3. PUMP UNIONS

2 Pumps of 1 HP are installed, each one of the pumps are grounded to the same grounding system which is installed through a conductor caliber #8.

- The motors are duly connected to the grounding fault system (Section 680-21)

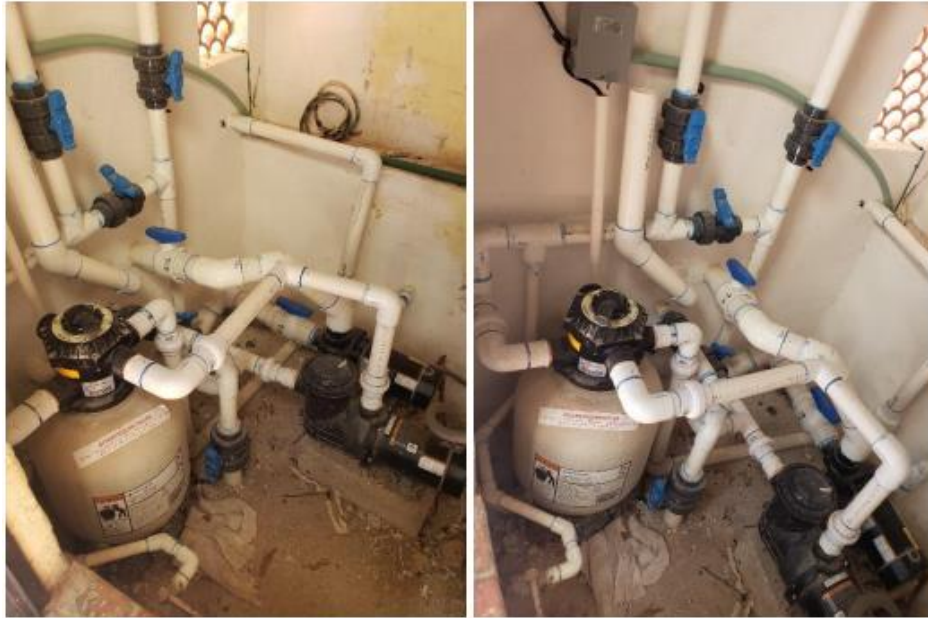
2.1.4. WATER UNION ACCESSORY CONNECTED TO THE FRONT PIPING

The union of each one of the pumps is observed connected to the water system with the adequate piping and correct accessories.

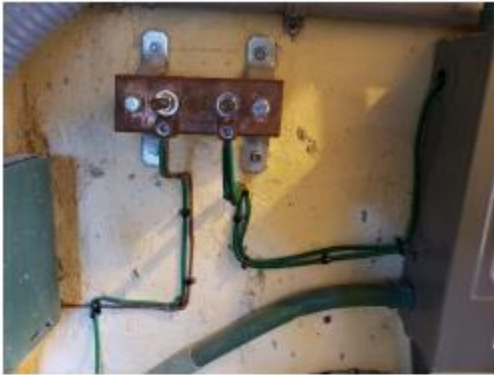
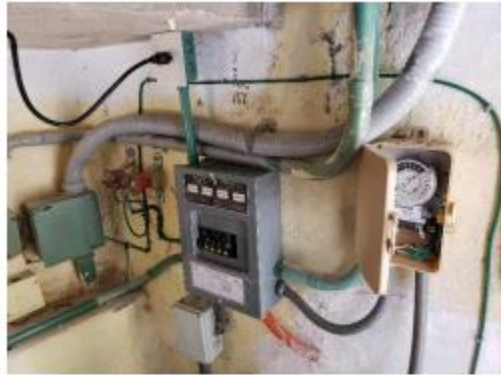
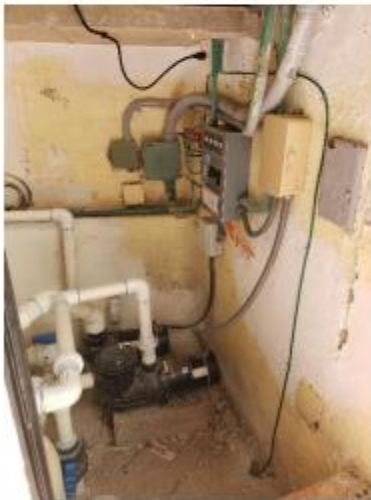
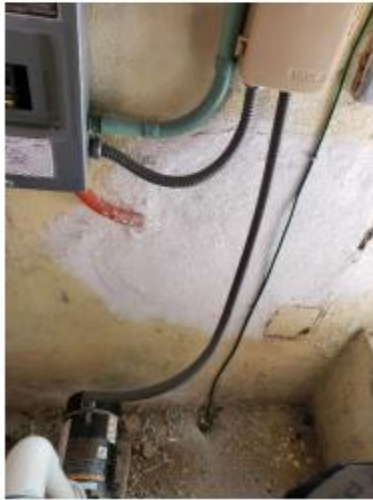
2.1.5. ORIGIN OF THE UNION GROUNDING SYSTEM

All the electrical equipment is duly connected to the grounding system.

- There is a copper rod to ensure that the ground fault system itself is duly grounded. (Section 680-6)
- All the electrical equipment is duly connected to the grounding system. (Section 680-6)
- All motors are duly connected to the grounding fault system (Section 680-21)
- The contacts are connected to the grounding fault system (Section 680-22)

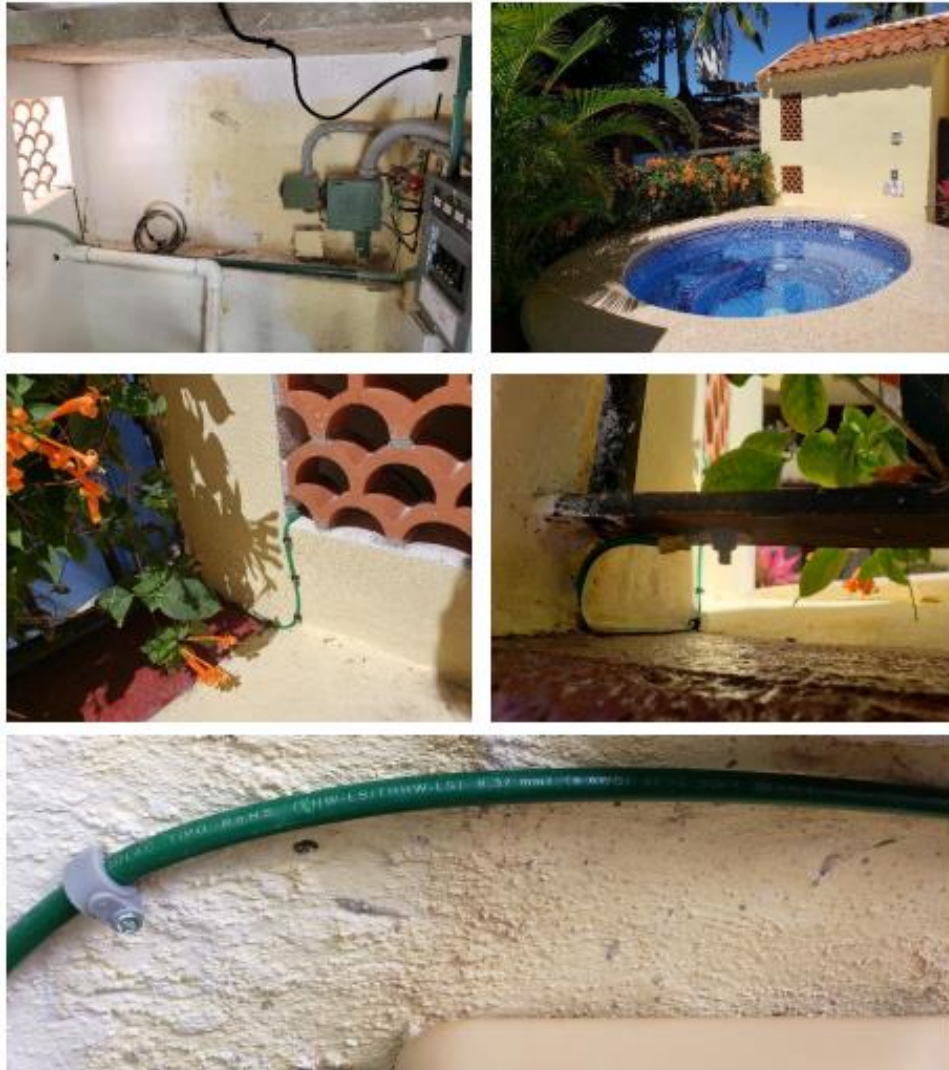
2.1.6. UNION OF RAILING WITH THE GROUNDING SYSTEM

The grounding system is connected to all the equipment and also to the structures around the jacuzzi, in this case with an equipotential union bridge to the railing by way of a caliber #8 conductor.

- There is a copper rod to ensure that the grounding fault system itself is duly grounded. (Section 680-6)
- The junction box is connected to the grounding fault system and complies with the necessary distance. (Section 680-24)
- Railings were united within the perimeter set forth (90 cm) by the standard through a caliber #8 conductor, this conductor forms an equipotential bonding bridge with the grounding fault system. (Section 680-26)

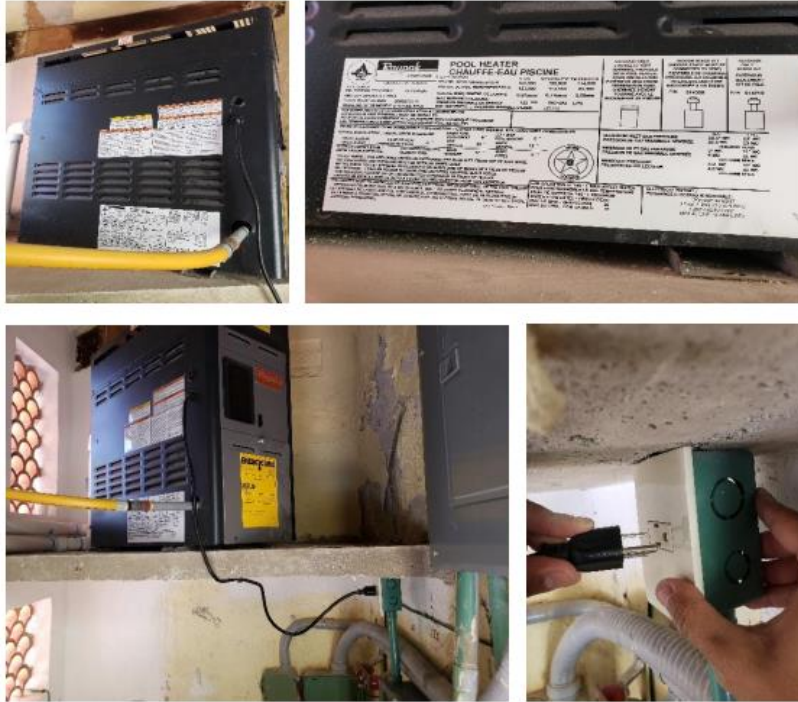
2.1.7. HEATER

Jacuzzi 1 has a pool heater, above is a picture of its data plate. The pool heater is connected to a contact which has a ground fault pin, this contact is grounded to the grounding fault system and which at the same time has a thermomagnetic switch with grounding fault detection.

- The contact is located at the correct distance. (Section 680-22(b)(1))
- The contact is connected to the grounding fault system and has a thermomagnetic switch with grounding fault detection. (Section 680-22(a))

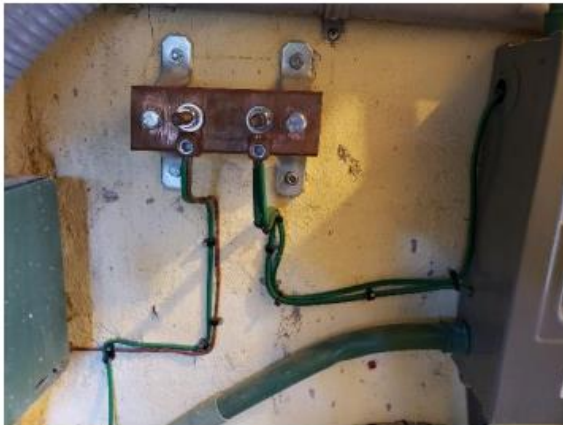
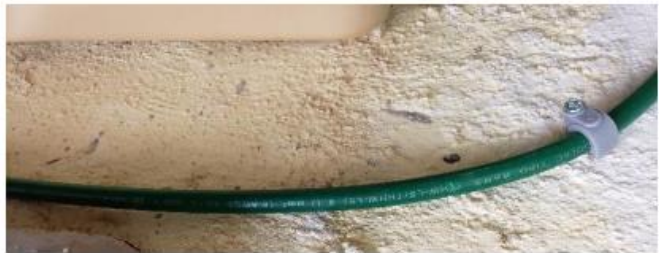
2.1.8 CALIBER #8 FOR THE UNION OF THE GROUNDING SYSTEM

The grounding system has naked cable which goes directly to the grounding fault system of the complex and has caliber #8 cable which is connected to a copper rod to ensure it is duly grounded.

- There is a copper rod to ensure that the grounding fault system itself is duly grounded. (Section 680-6)
- A caliber #8 conductor is being used as union bridge. (Section 680-26)

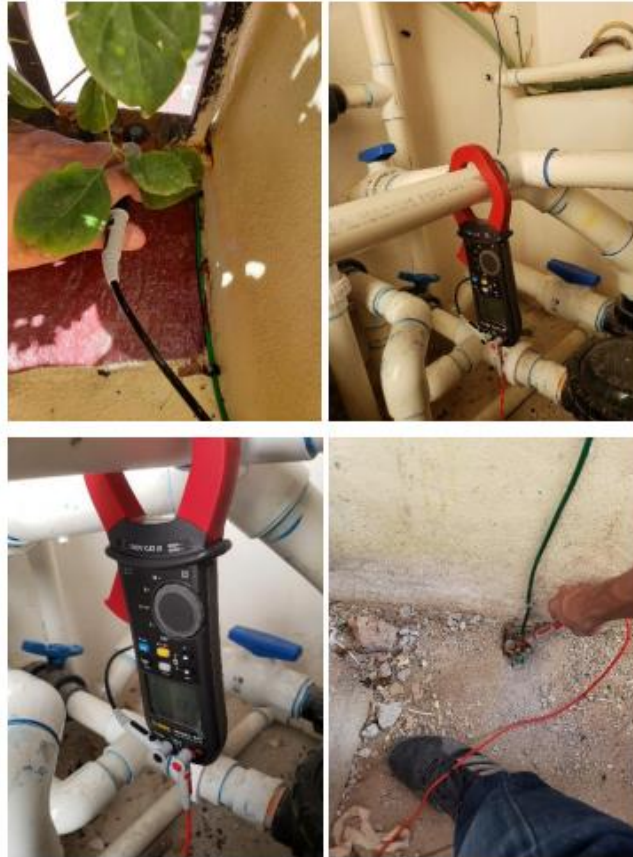
2.1.9 CONTINUITY TEST

A test was performed to measure the continuity between the railing located in the area of the jacuzzi and the grounding system it has, the results indicated that indeed continuity exists in the system and that it is correctly grounded.

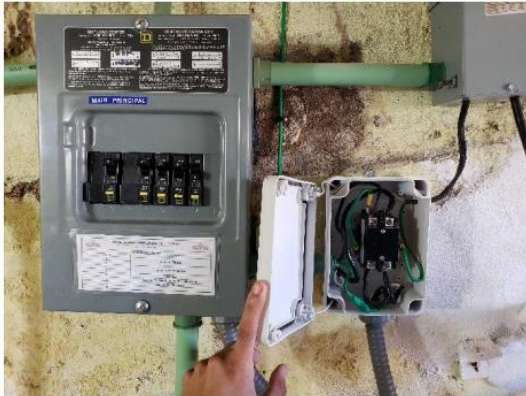
2.2.1. GENERAL LOAD CENTER

(V) L1-N =	115
(V) L2-N =	122
(V) L1-L2 =	210

(A)L1 =	15.6
(A)L2 =	25.0

It has a QO816L100F load center with five thermomagnetic switches with grounding fault detection, two thermomagnetic switches are 20A and three thermomagnetic switches are 15A. The load center is supplied by caliber 8 AWG conductors, the grounding system utilizes the same caliber conductor.

- All the switches of this load center are adequate, all are thermomagnetic with grounding fault detection of the adequate ampacity. (Section 680-40)
- There is a copper rod to ensure that the grounding fault system itself is duly grounded. (Section 680-6)

- There is a directory of circuits on panels. Each circuit is legible indicating its purpose or specific use, evident and clear (Section 408-4 a).

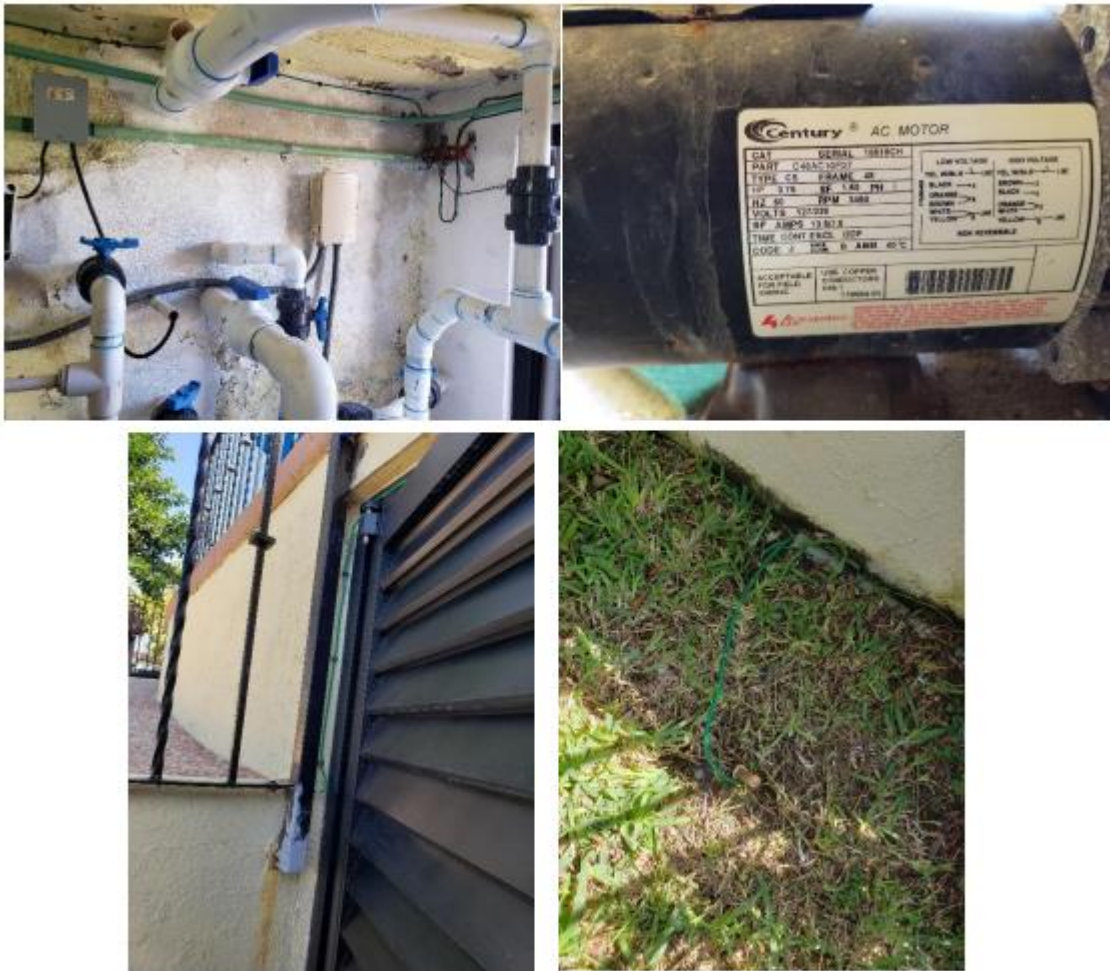
2.2.2 EQUIPMENT

2 Pumps of 0.75 HP are installed to supply the jacuzzi. It also has 2 luminaires for the jacuzzi, one service contact which is for the heater and one fountain pump for the lighting of the jacuzzi. (Section 680-22)

- The conductor which supplies the pool luminaire is duly connected and grounded.
- The motors have liquid tight flexible pipes for each one of them, this ensures greater safety on the installation (Section 680-21a)
- The motors are duly connected to the grounding fault system. (Section 680-21)

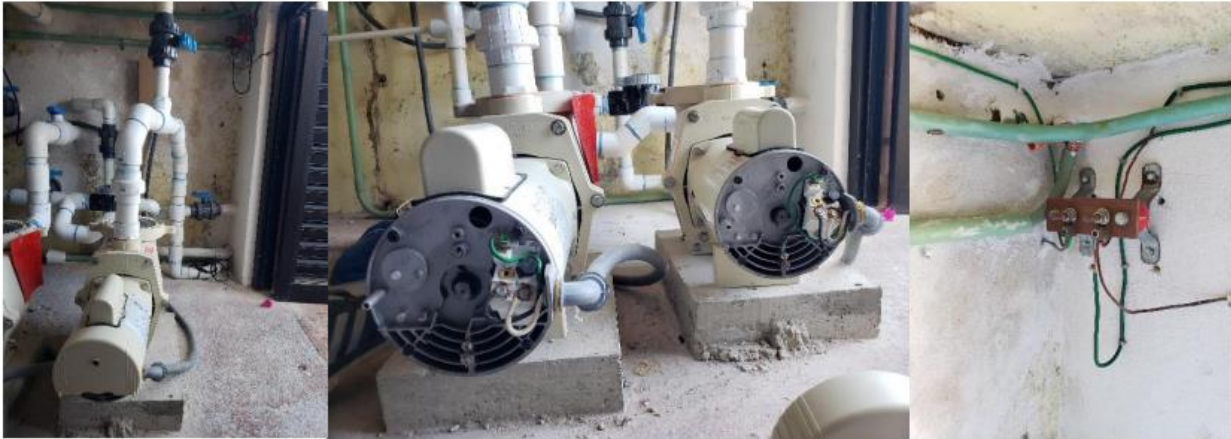
2.2.3. PUMP UNIONS

Jacuzzi 2 has 2 pumps of 0.75 HP installed, each one of the pumps are grounded to the same grounding system. The pumps have a conductor caliber #8 to be grounded.

- The motors are duly connected to the grounding fault system. (Section 680-21)

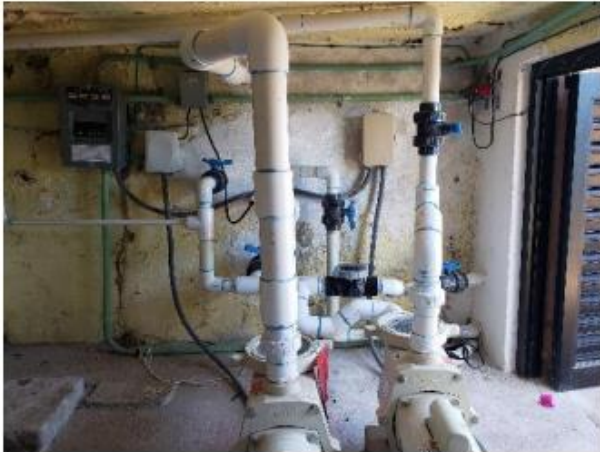
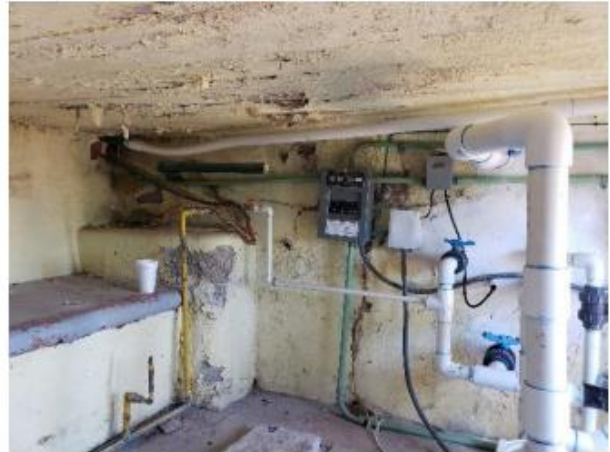
2.2.4. WATER UNION ACCESSORY CONNECTED TO THE FRONT PIPING

Each one of the pumps is connected to the water system with the adequate piping and correct accessories.

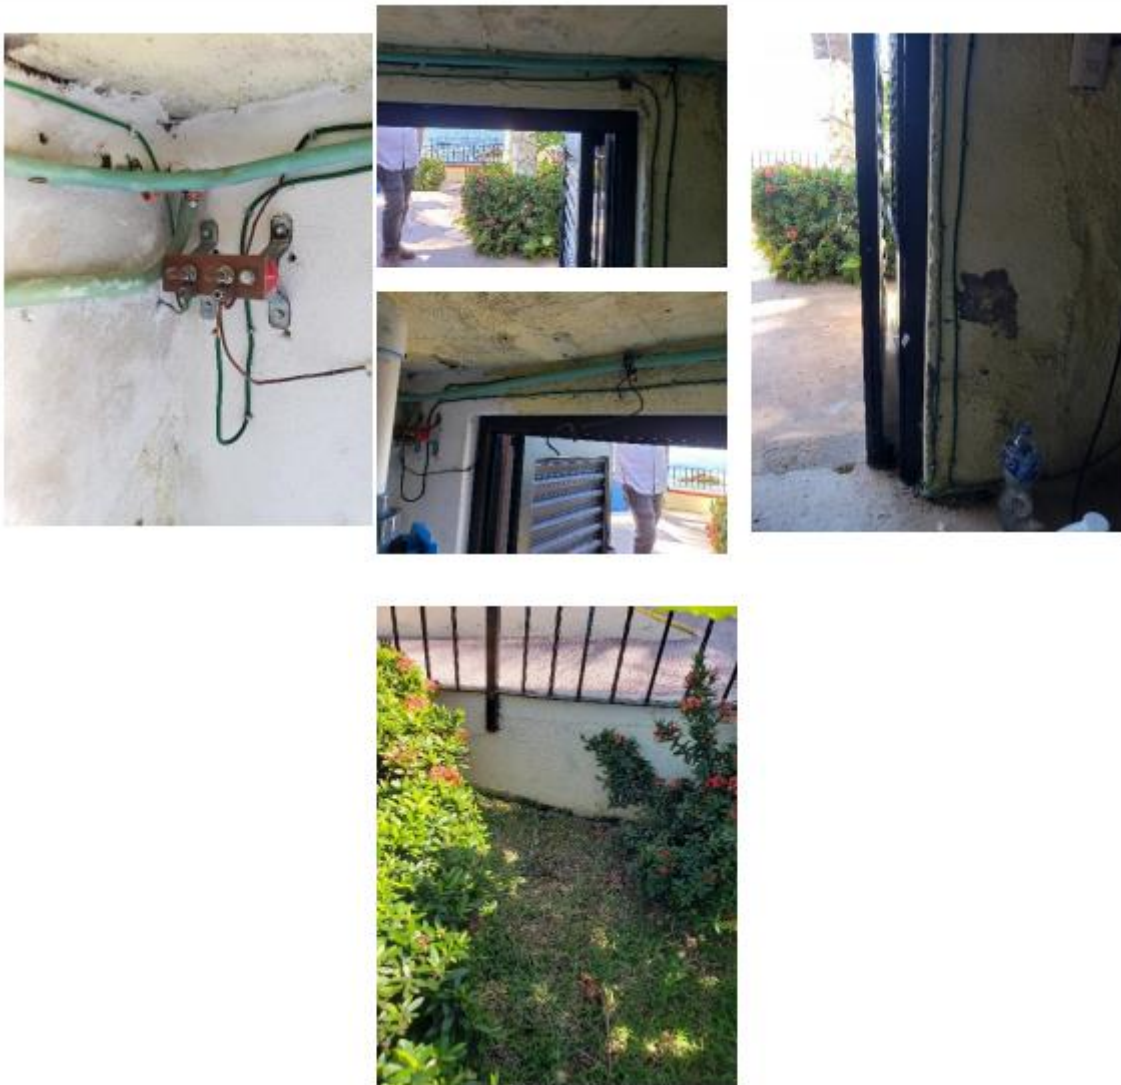
2.2.5. ORIGIN OF THE UNION GROUNDING SYSTEM

All the electrical equipment is duly connected to the grounding system of the Lindo Mar complex and in addition, has a copper rod which is likewise grounded.

- There is a copper rod to ensure that the ground fault system itself is duly grounded. (Section 680-6)
- All the electrical equipment is duly connected to the grounding system. (Section 680-6)
- All motors are duly connected to the grounding fault system (Section 680-21)
- The contacts are connected to the grounding fault system (Section 680-22)

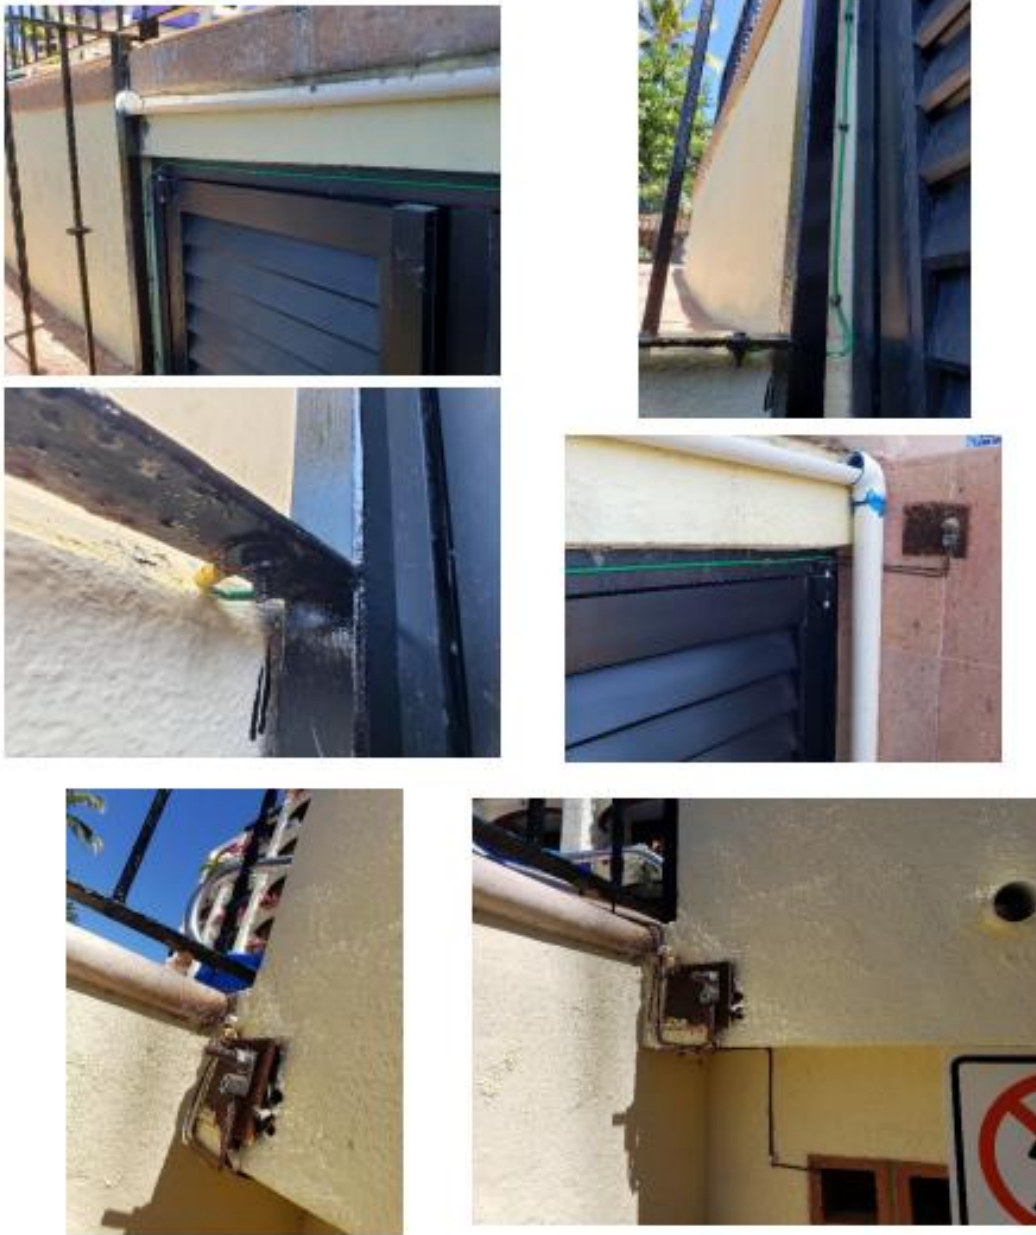
2.2.6. UNION OF RAILING WITH THE GROUNDING SYSTEM

Structures located around jacuzzi 2 are grounded to the same grounding system, there is an equipotential union bridge to the railing by way of a caliber #8 conductor. There are two railings on the jacuzzi and both are connected to the grounding system.

- There is a copper rod to ensure that the grounding fault system itself is duly grounded. (Section 680-6)
- The junction box is connected to the grounding fault system and complies with the necessary distance. (Section 680-24)
- Railings were united within the perimeter set forth (90 cm) by the standard through a caliber #8 conductor, this conductor forms an equipotential bonding bridge with the grounding fault system. (Section 680-26)

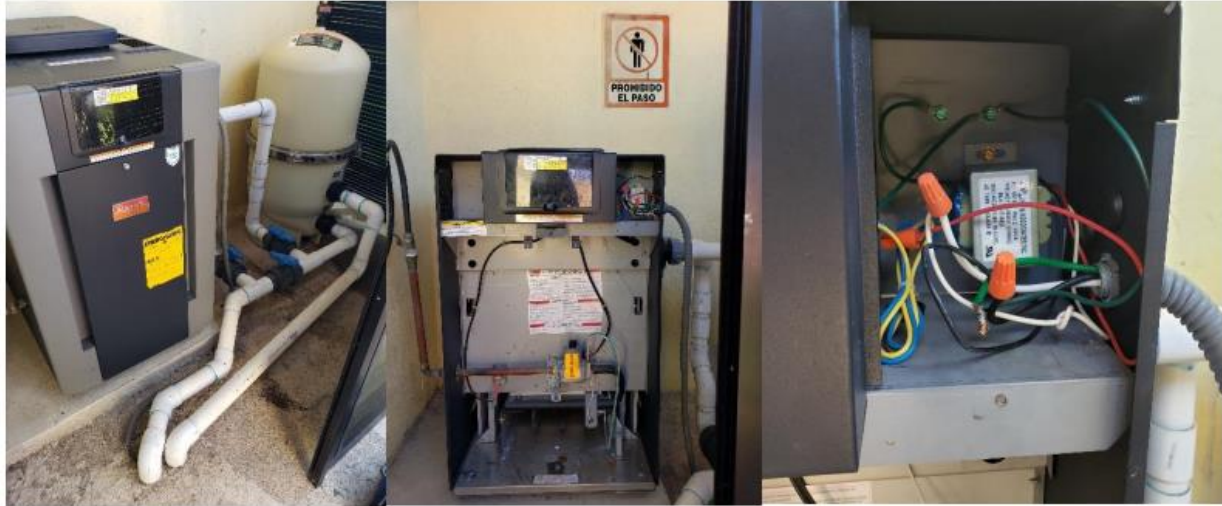
2.2.7. HEATER

In the same manner, Jacuzzi 2 has a pool heater. The pool heater is connected directly to the load center, which has a thermomagnetic switch with grounding fault detection.

- The equipment is grounded and has the necessary distance to be able to be installed. (Section 680-27)
- It has a thermomagnetic switch with grounding fault detection. (Section 680-22(a))

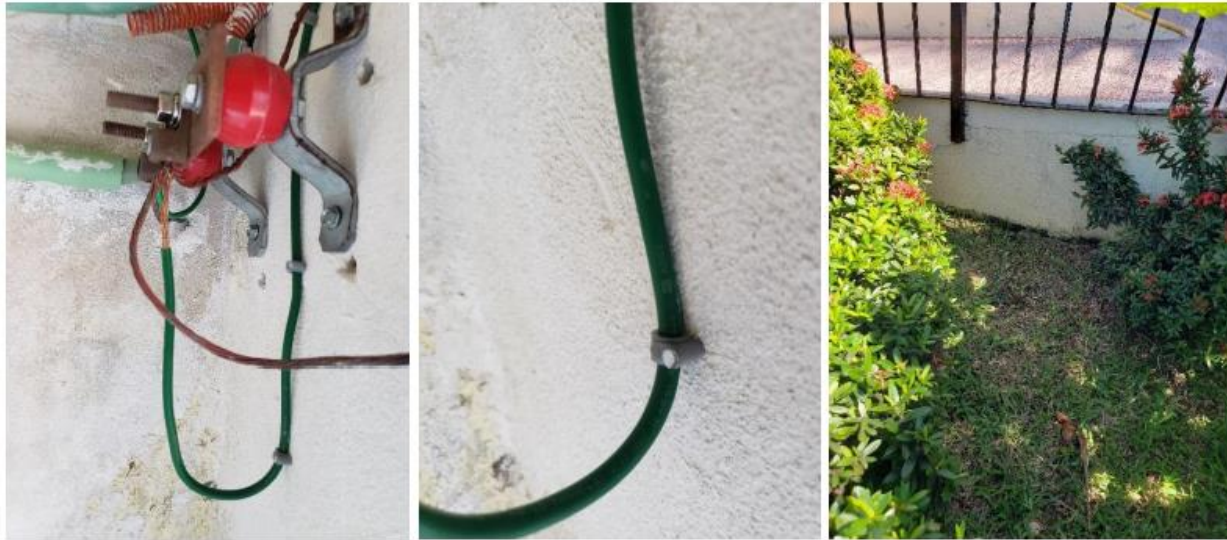
2.2.8 CALIBER #8 FOR THE UNION OF THE GROUNDING SYSTEM

The grounding system has naked cable which goes directly to the grounding fault system of the Lindo Mar complex and in addition has caliber #8 cable which is connected to a copper rod to ensure it is duly grounded.

- There is a copper rod to ensure that the grounding fault system itself is duly grounded. (Section 680-6)
- A caliber #8 conductor is being used as union bridge. (Section 680-26)

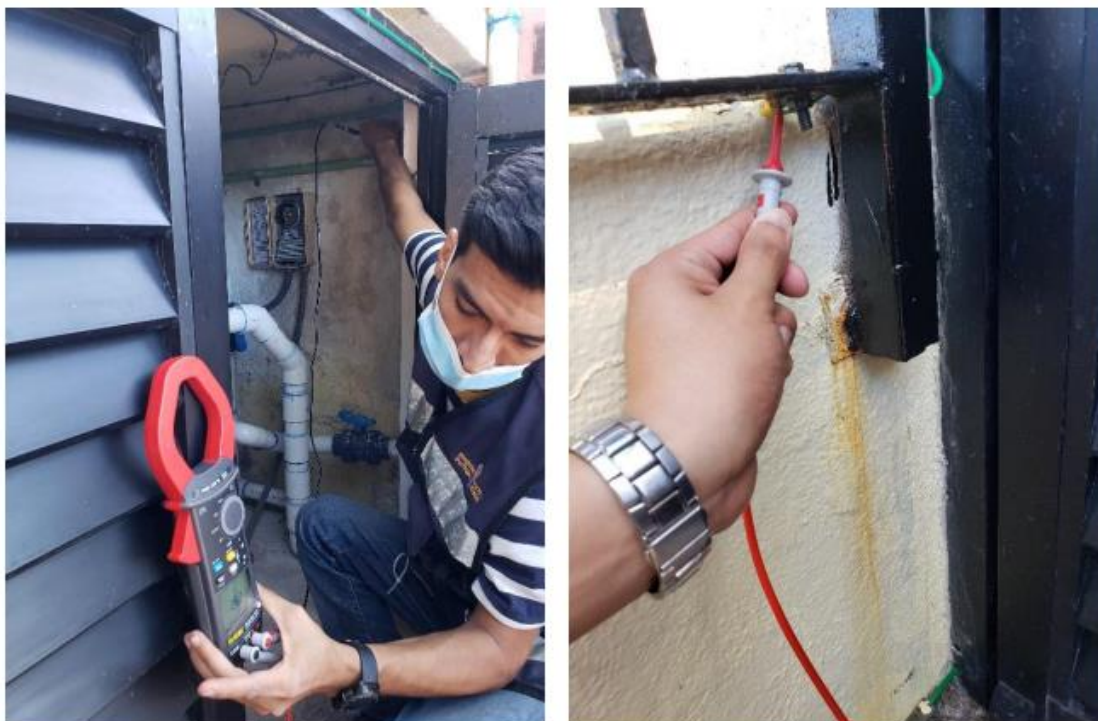
2.2.9 CONTINUITY TEST

A test was performed to measure the continuity between the railing located in the area outside the jacuzzi and the grounding system; the results indicated that indeed continuity exists in the system and that it is correctly grounded.
