Lindo Mar Resort

Annual Review Without Site Visit

Project Description

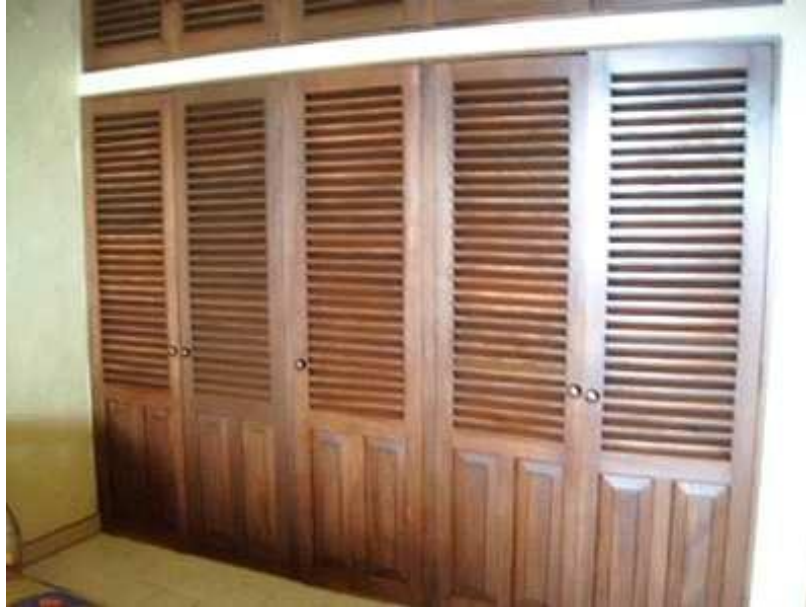
The Closet Doors are made of wood and are in overall very good condition, especially considering their age. Replacement of these doors has not been included in the Study.

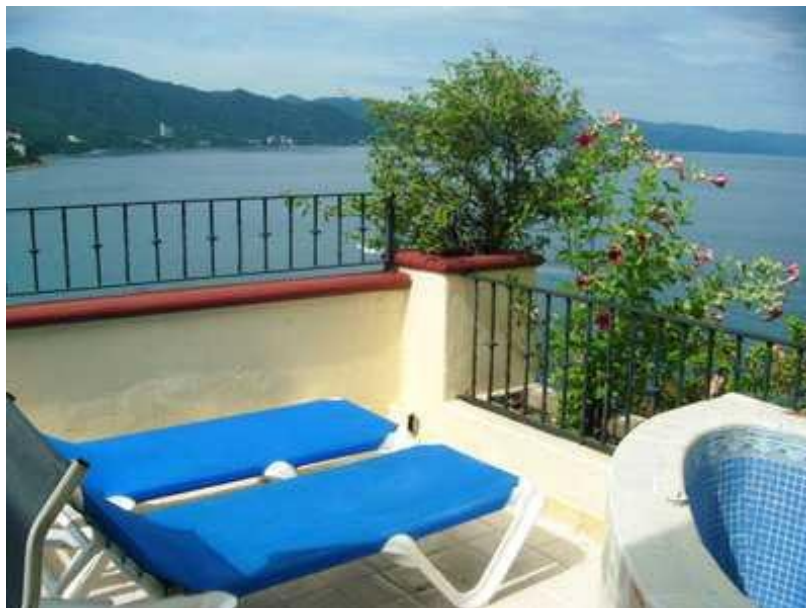
The Patio Category Components Include the Patio Furniture Replacement and the Tile Replacement. All One Bedroom Units have a Patio Table and Chairs. The Two and Three Bedroom Units have a Patio Table and Chairs, Lounge Chairs and some units have their own Spa. The Wrought Iron Railing Painting and Repairs and Exterior Stucco Painting have been included in the Building Exterior Category.

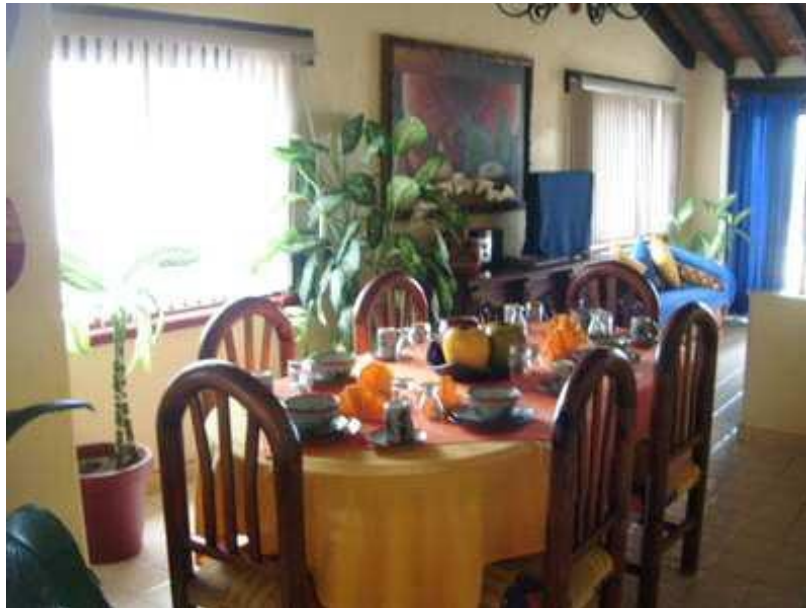
Complete Replacement of all Furniture will not be done with the Remodel. A Furniture Replacement Contingency has been included in the Study to Replace Furniture as needed.

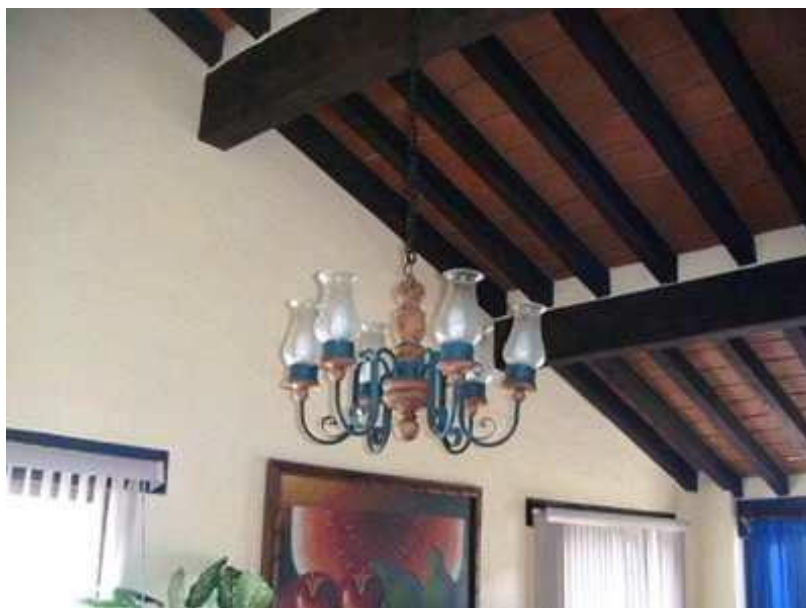
Electrical and Lighting Replacement has been included with the Interior Remodel costs.

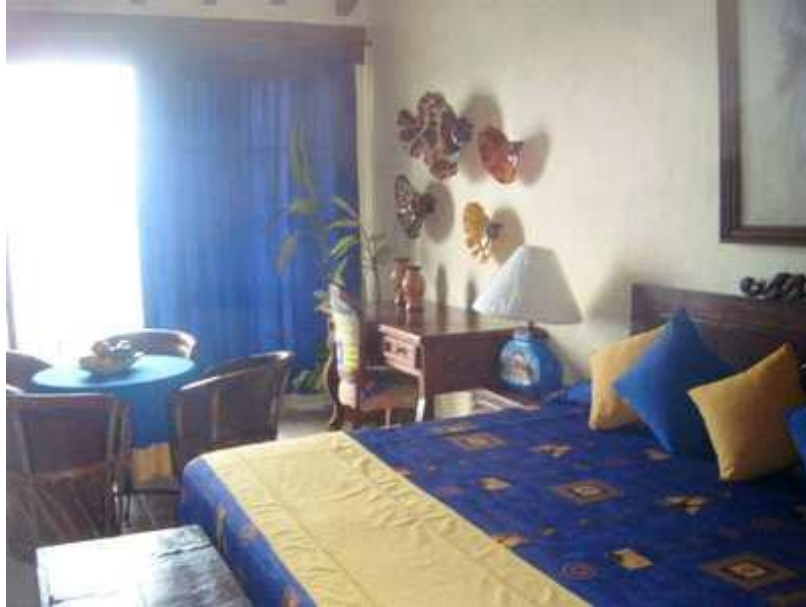
The Bedrooms Remodel includes new Mattresses, Bedding, and some Furniture Replacement.

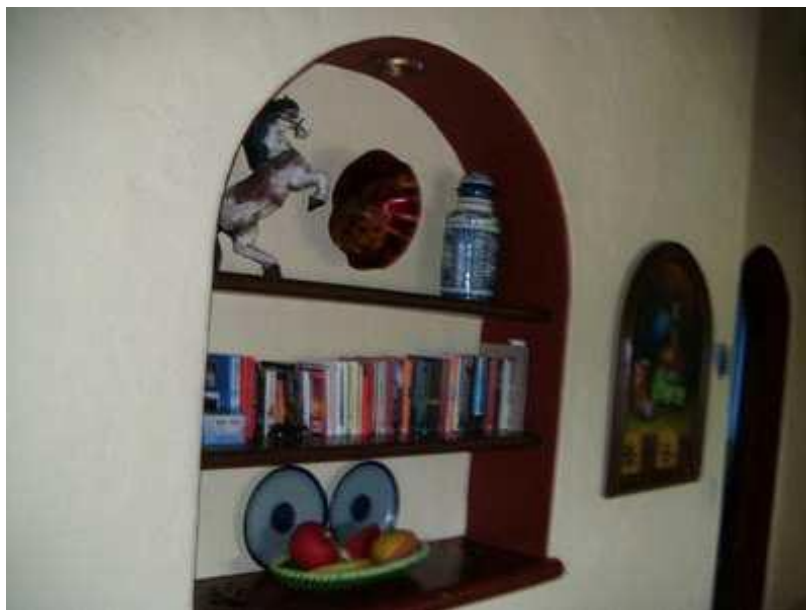
Replacement of the Art Work and Decorations is scheduled with the Unit's Remodel and then to be done as needed in the future.

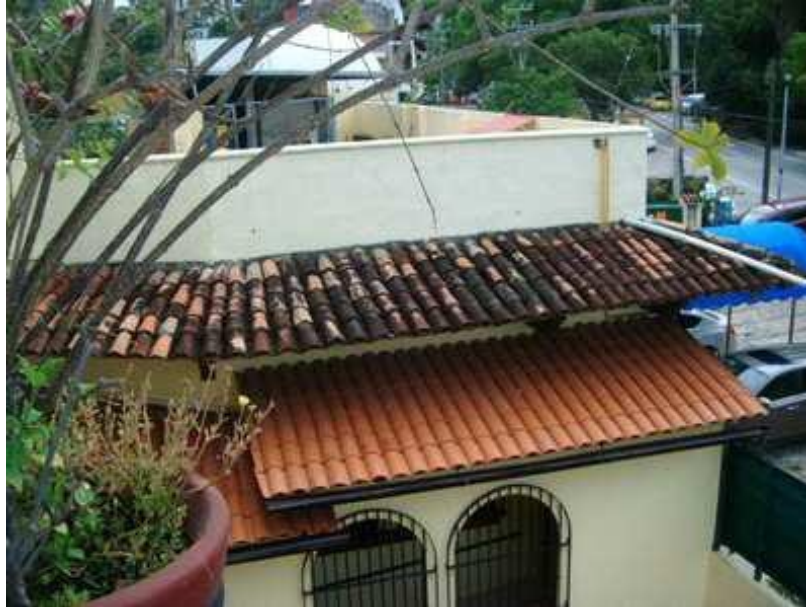
Tile Roof Replacement has been included as a Component in the Study. The Tile Roof at the lower section shown in this photo was built recently. The older Roof, above, is discolored and could be replaced at the Board of Directors discretion.

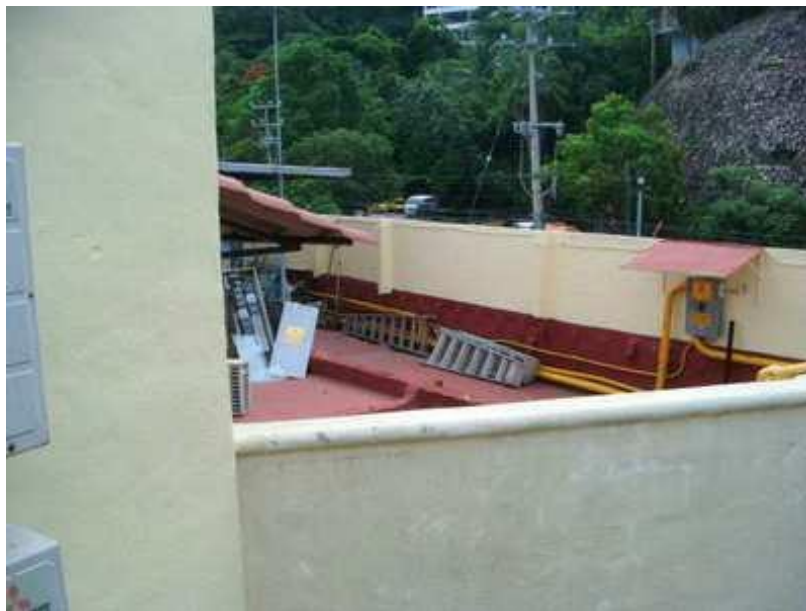
The Flat Roof Surface is sealed by the Maintenance Staff. Replacement or Repair of this Roof Surface has not been included in this Study.

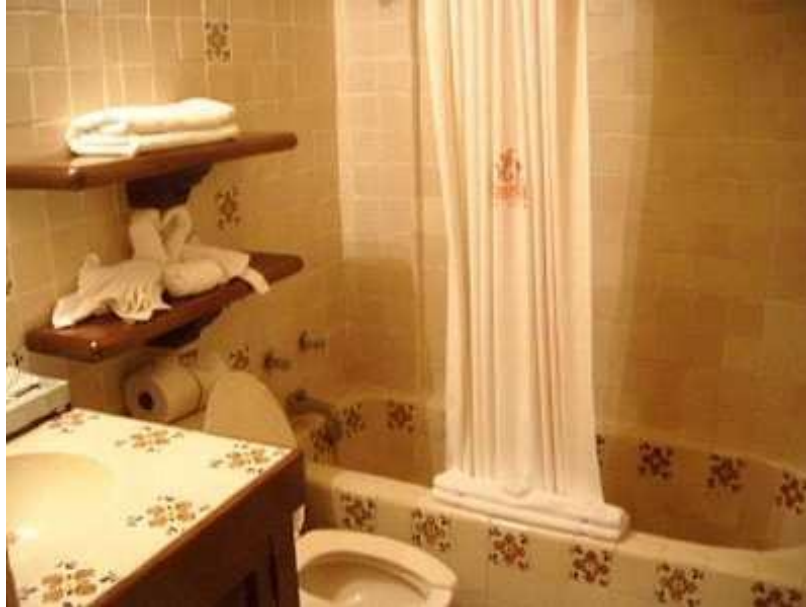
The Bathroom Remodel is a part of the Units Remodel to be scheduled in Phases.

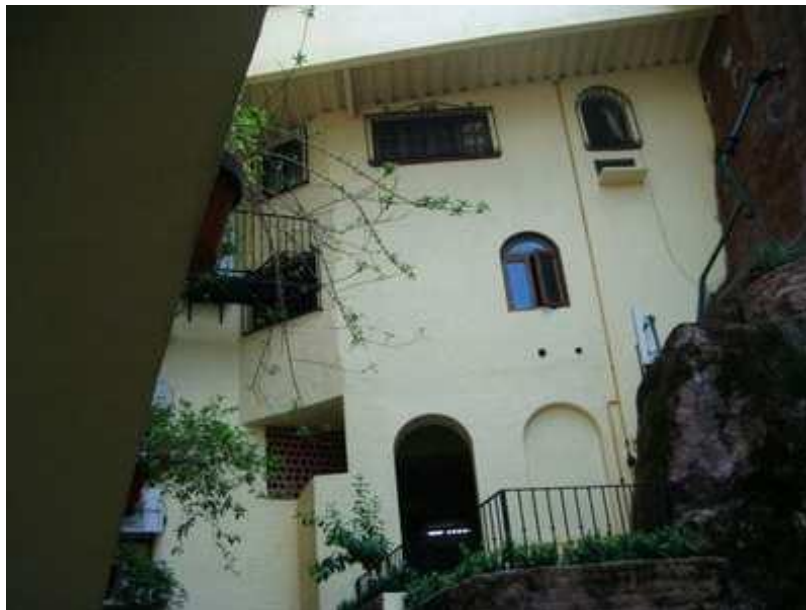
The South Side of the Building was painted recently with the addition of the Ramp to the Lobby.

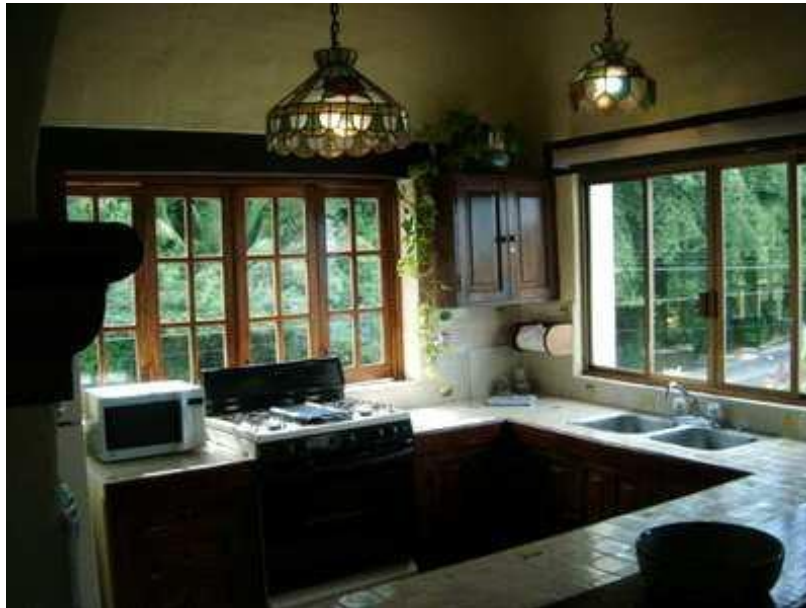
The Kitchen Renovation is scheduled to be done as a part of the Remodel. An Appliance Contingency for future Replacement has been included in the Study.

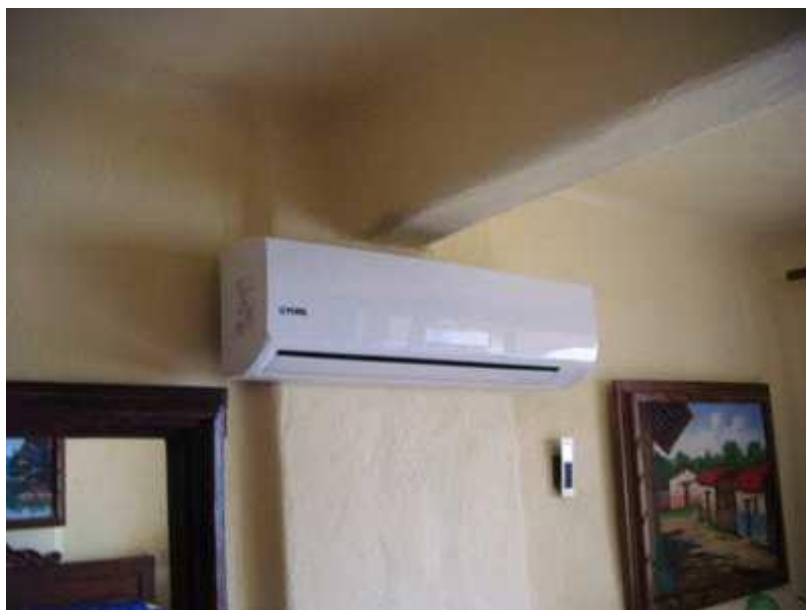
"Mini- Split" Coolers were installed in the South Side of the Building in 2013. "Mini-Split" Units are scheduled to be replaced in the South Side Units in 2015. These units have an estimated useful life when new of 8 years. Future replacement of all units has been included in the Study.

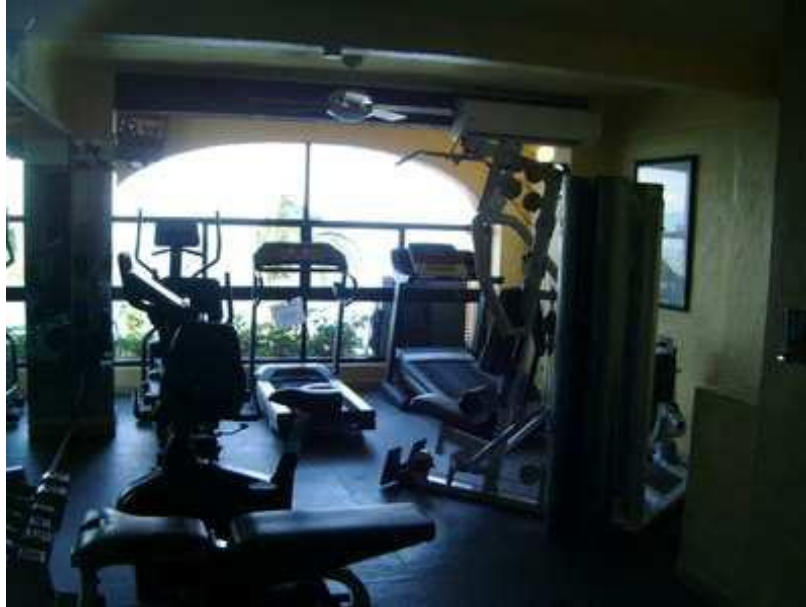
Complete replacement of all Exercise Equipment has not been scheduled. Instead, Replacement has been included in the Study as a Contingency Fund to replace individual pieces of Equipment, as needed. The Exercise Room Components also include Flooring Replacement and Television Replacement. Wall Painting, Lighting and Window/ Door Replacement has been included with the Interior of Units Remodel Costs.

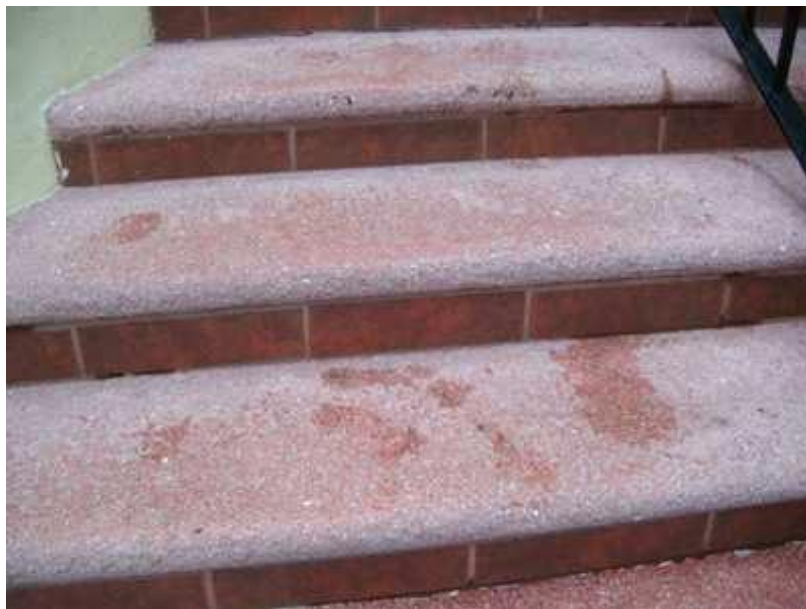
Exterior and Interior Concrete Stair Resurfacing and Tile Replacement is done by the Maintenance Staff and considered an Operational Expense.

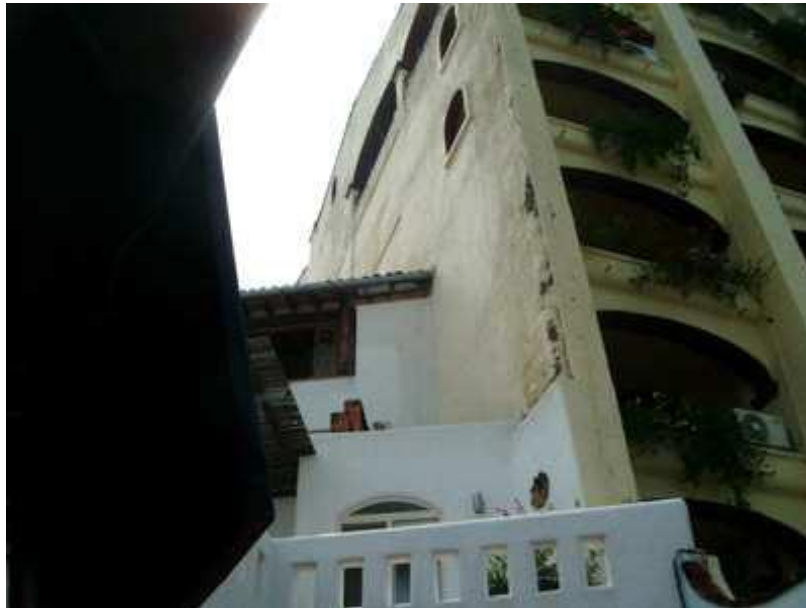
Future Painting of the Building has been included in this Study.

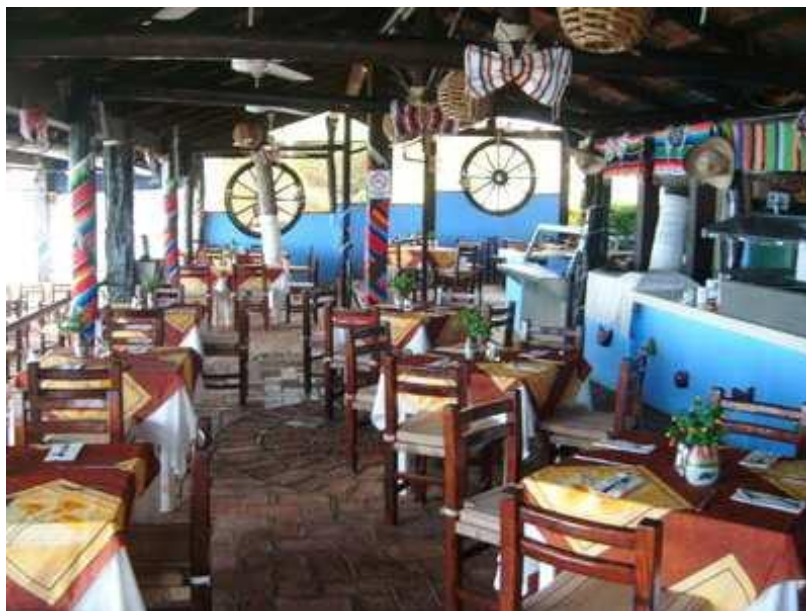
The Restaurant Maintenance is the HOA Responsibility. The Restaurant Re-Build and Renovation has been scheduled to be done in 5 years.

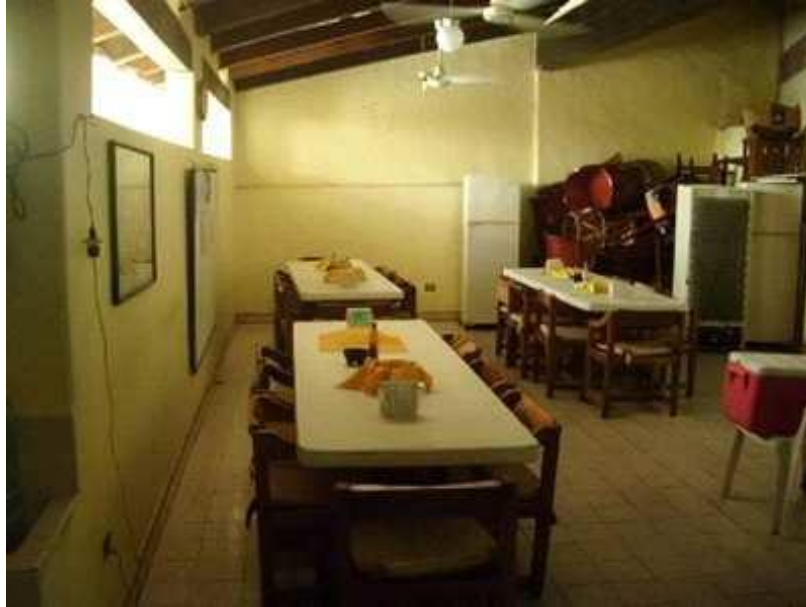
The Staff Break Room Area Remodel is included with the "General Building Interior" components.

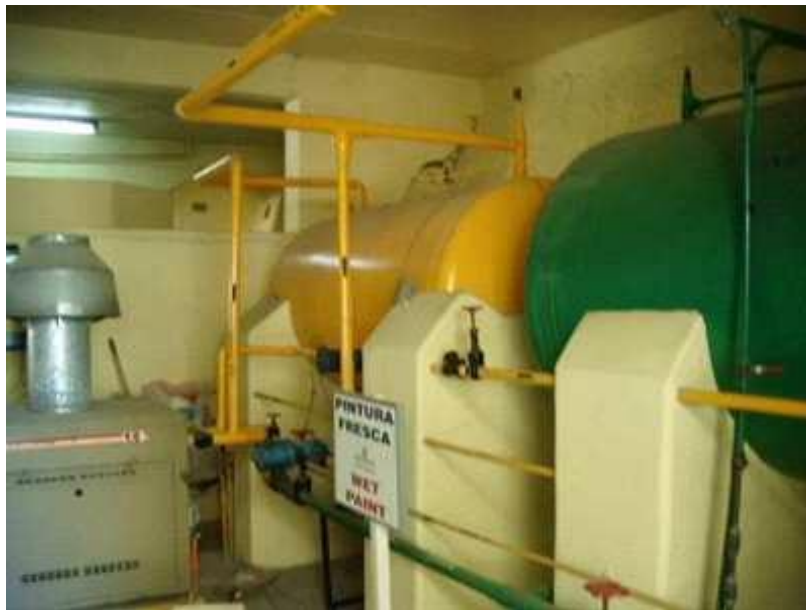
The Hot and Cold Water Tank System Replacement has been included in the Study under the Category "Building Interior" along with remodel of the Office Areas and Storage.

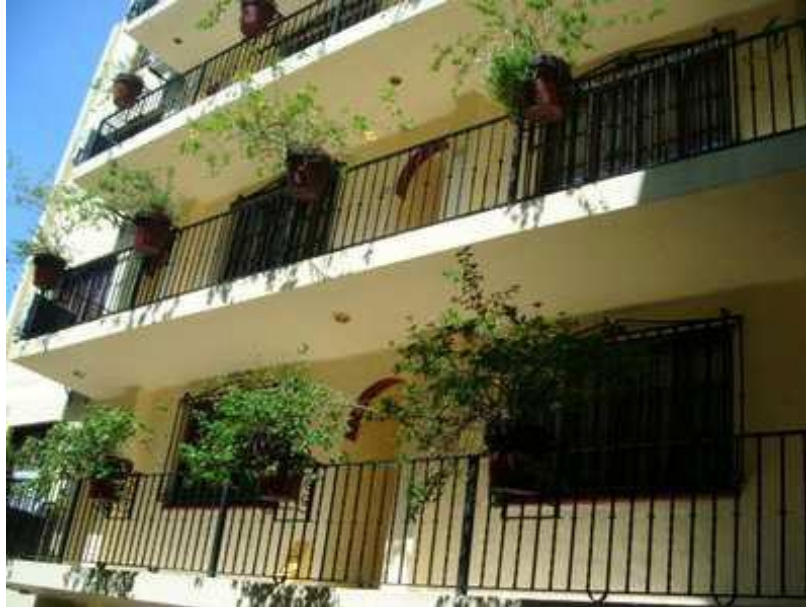
The Wrought Iron Railing Painting and Repairs are Scheduled to be completed when the Exterior of the Building is painted. Window and Door Replacement has been included in the Study along with the Remodel phases.

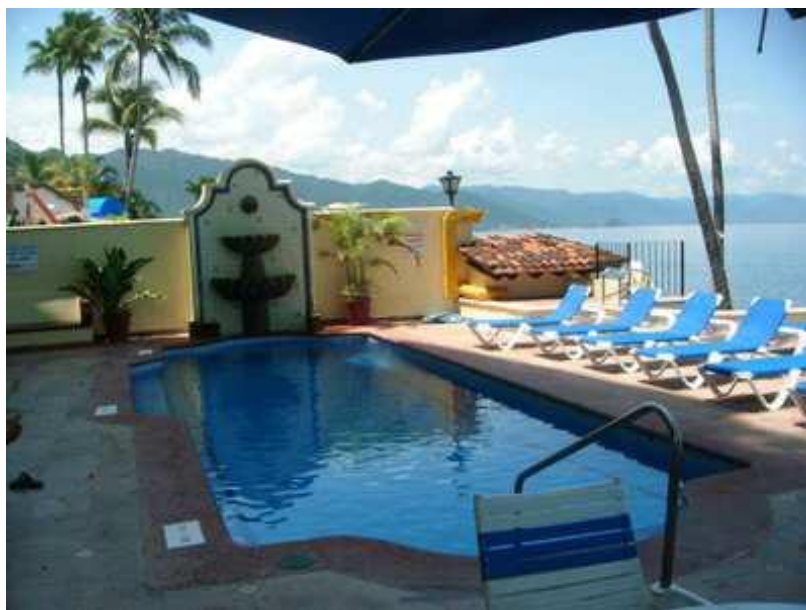
All Pool and Spa Components have been included in the Study. These Components include the Pool and Spa Tile Resurface, Filters, Pumps, Heaters, Pool Furniture and Decking Repairs.

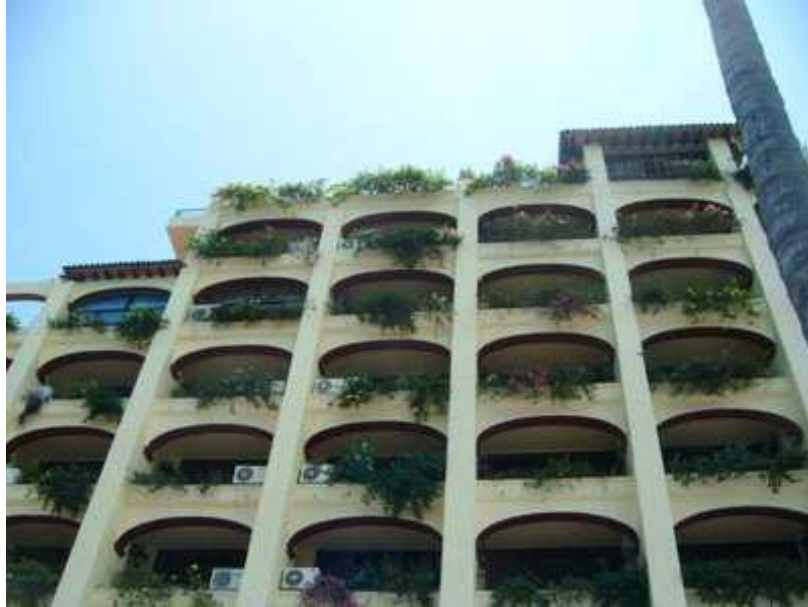
The "Mini-Split" Units on the South Side were replaced recently. When the Units are replaced on the North Side of the Building, the compressor will be moved to the interior deck area and will not be blocking the Patio of the units. Landscaping at the building Exterior Patios are considered an Operational Expense.

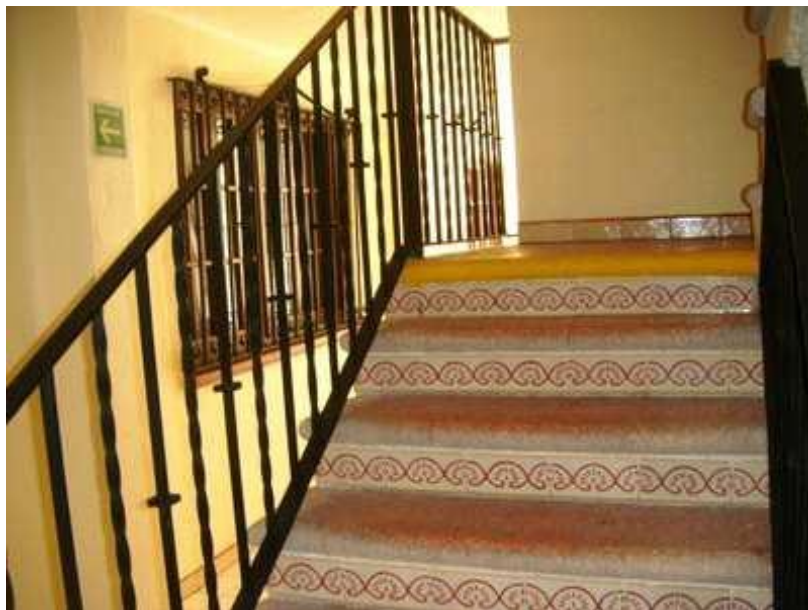
Complete Replacement of the Wrought Iron Railings and Window Guards has not been included. Painting and Repairs have been scheduled. If the Wrought Iron is properly protected and repaired the estimated remaining useful life should be more than 30 years.

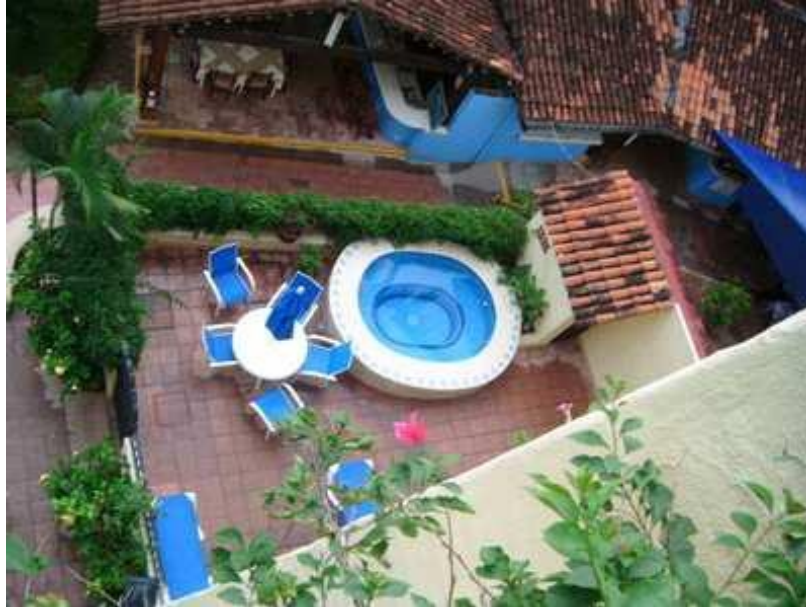
Several units have their own Spas. Maintenance of the Spas has been included in the Pool Area Category of the Study.

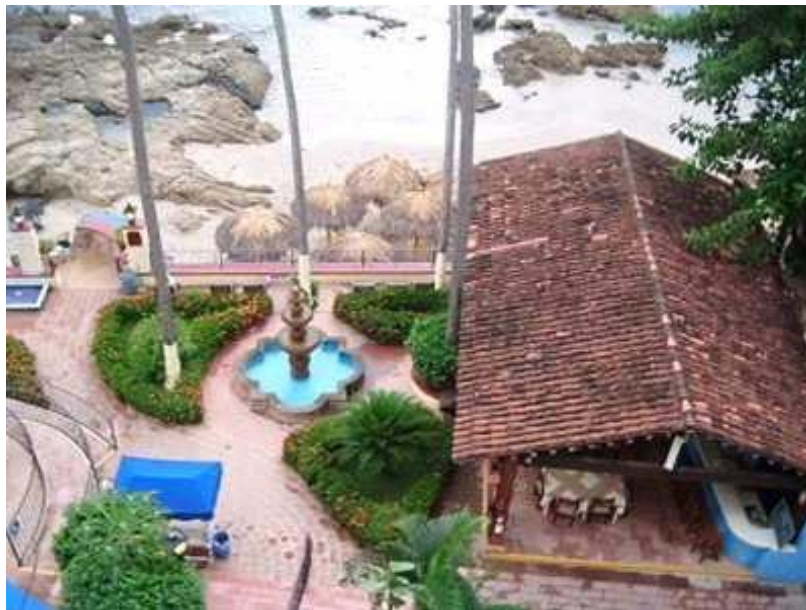
Replacement of the Restaurant Tile Roof has been included in the Study. However, the Time Frame and Plan may change when the Restaurant is Re-Built.

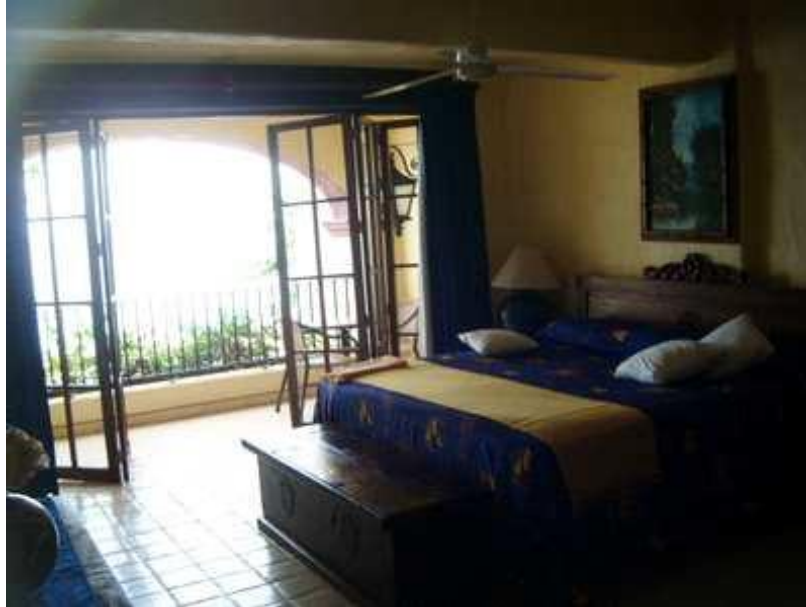
The Two and Three Bedroom Units have 2 Sets of the Glass Doors. Replacement of all Glass Doors has been included as part of the Interior Unit Remodel

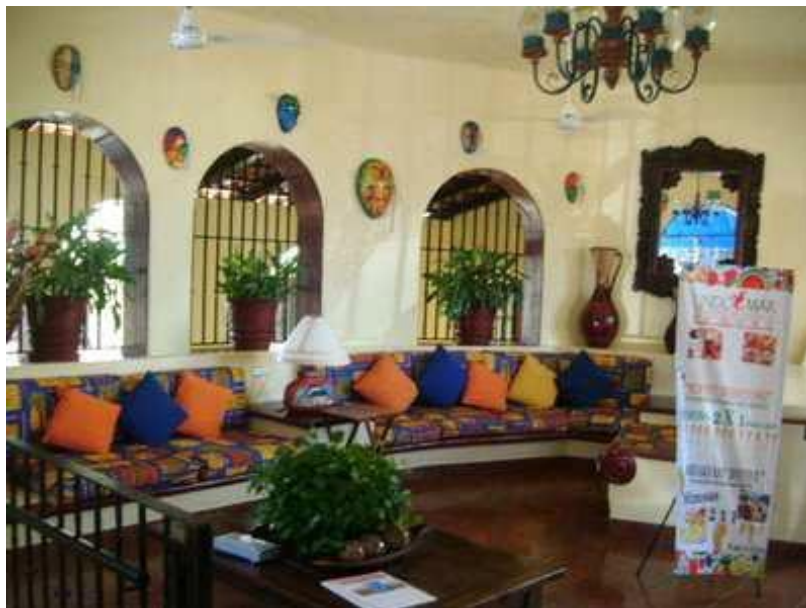
All Lobby Area Components have been included in the Study. A Full Renovation of the Lobby Area has not been scheduled.

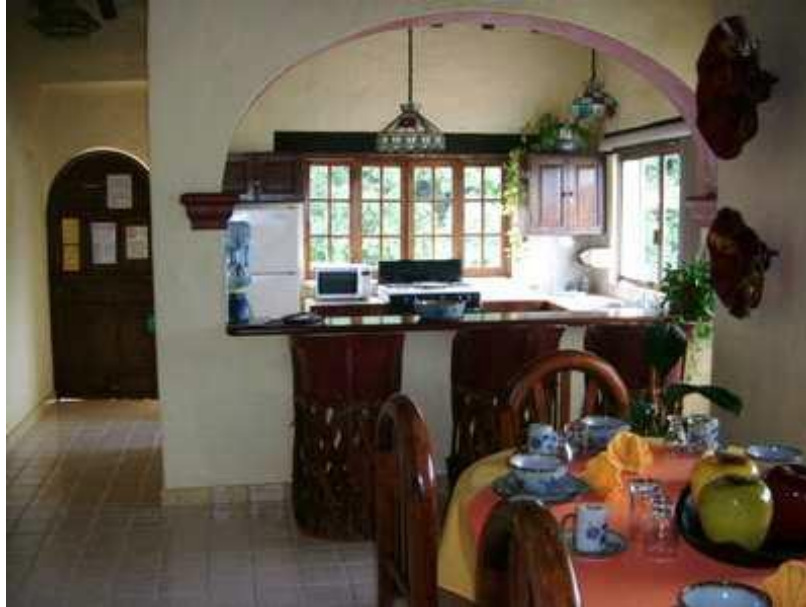
The Resort is well maintained and in overall good condition.

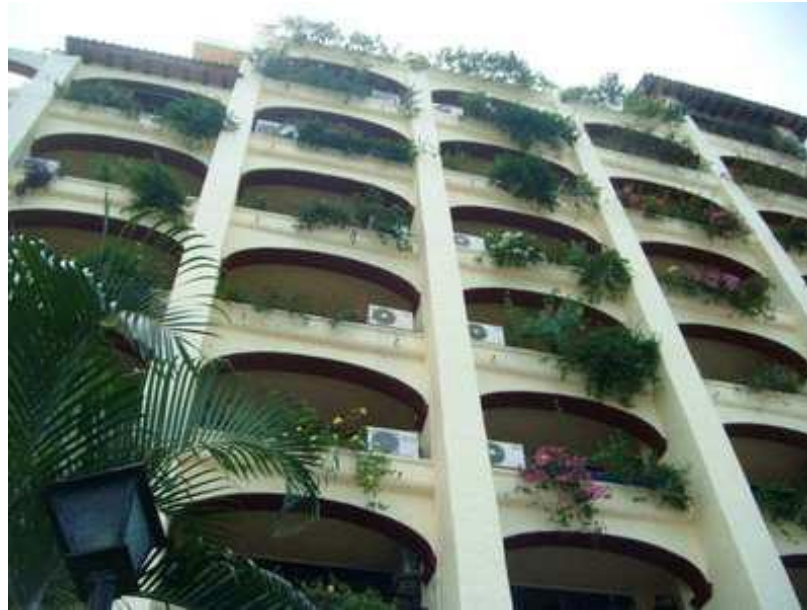
Component	Year Scheduled	Units	Cost Per Unit	Today's Cost	Estimated Remaining Useful Life (Years)	Estimated Life When New (Years)
Building Exterior - Entry Canopy	2022	1 unit	200.00	200.00	5	6
Building Exterior - Entry Smoking Area Bench and Cover	2046	1 unit	1000.00	1000.00	29	30
Building Exterior - Painting Exterior Highway Side (Front of Building)	2020	all	3500.00	3500.00	3	7
Building Exterior - Painting Exterior North Side (Done 2016)	2023	all	3500.00	3500.00	6	7
Building Exterior - Painting Exterior Ocean Side	2020	all	3500.00	3500.00	3	7
Building Exterior - Painting Exterior South Side	2023	all	3500.00	3500.00	6	7
Building Exterior - Roof Tile Replacement (Cost Per Tile)	2027	all	0.75	11250.00	10	40

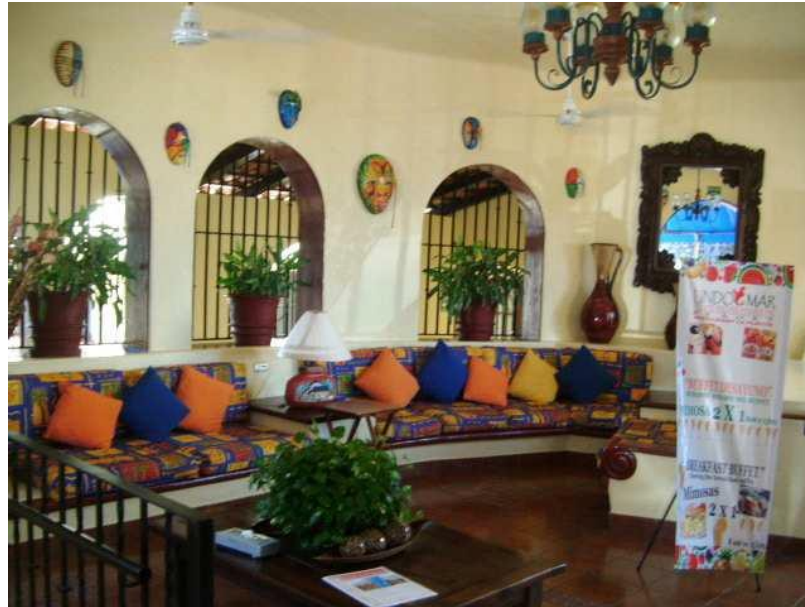
Component	Year Scheduled	Units	Cost Per Unit	Today's Cost	Estimated Remaining Useful Life (Years)	Estimated Life When New (Years)
Building Interior - Component: Employee Area Mini-Split Units Replacement	2018	5 units	1400.00/unit	7000.00	1	10
Building Interior - Component: Guest and Pool Remodel Restrooms	2026	4 units	2000.00/unit	8000.00	9	10
Building Interior - Component: Housekeeping Area Remodel Flooring	2022	as needed	2500.00	2500.00	5	30
Building Interior - Component: Manager`s Office Desks	2019	2 units	300.00/unit	600.00	2	10
Building Interior - Component: Manager`s Office Equipment	2021	as needed	2500.00	2500.00	4	5
Building Interior - Component: Manager`s Office Equipment	2019	2 units	2500.00/unit	5000.00	2	10
Building Interior - Component: Storage and Maintenance Area Remodel Flooring	2022	1 unit	2500.00	2500.00	5	30
Building Interior - Electrical and Lighting (LED Lights Installed 2016)	2036	as needed	5000.00	5000.00	19	20

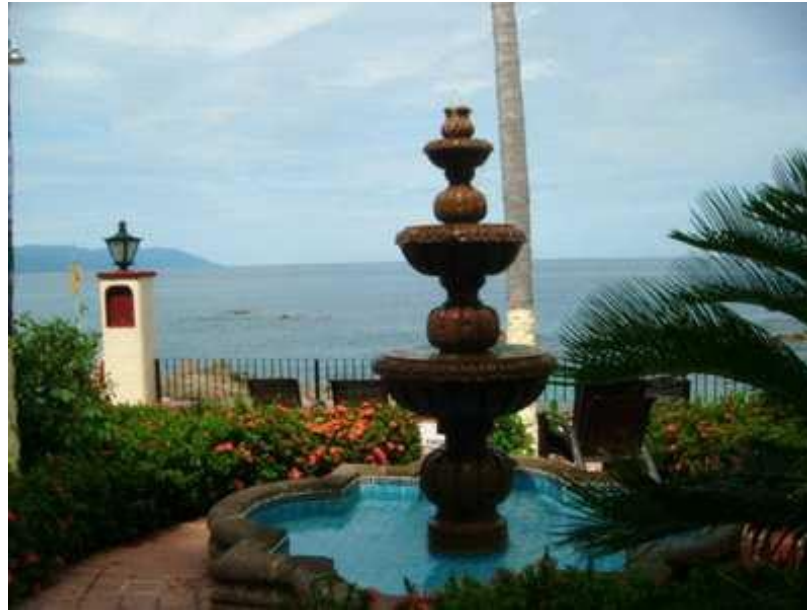
Component	Year Scheduled	Units	Cost Per Unit	Today's Cost	Estimated Remaining Useful Life (Years)	Estimated Life When New (Years)
Common Area - Component: Back Patio Brick Surface Replacement or Repairs	2022	as needed	1000.00	1000.00	5	10
Common Area - Component: Back Patio Lighting	2037	as needed	1000.00	1000.00	20	30
Common Area - Component: Fountain Replacement	2022	as needed	500.00	500.00	5	10
Common Area - Component: Palapas Repair or Replacement	Annual	as needed	200.00	200.00	0	1

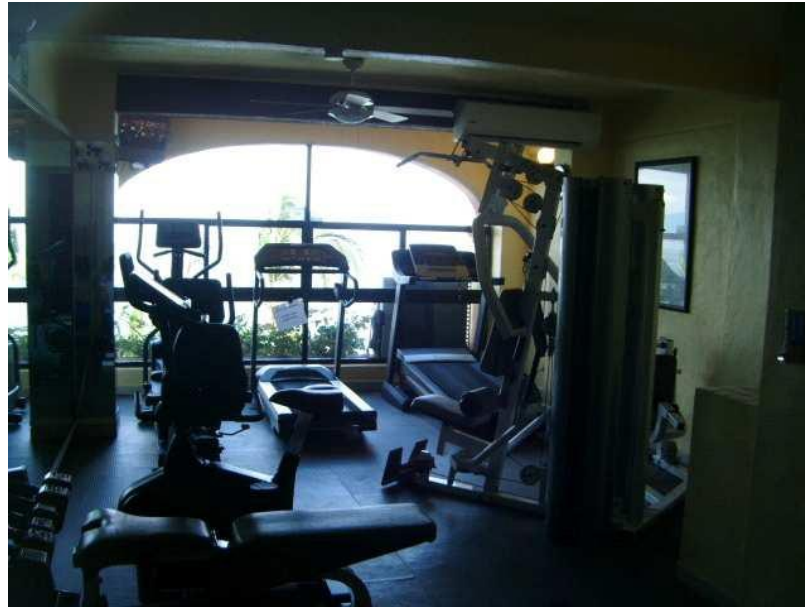
Component	Year Scheduled	Units	Cost Per Unit	Today's Cost	Estimated Remaining Useful Life (Years)	Estimated Life When New (Years)
Exercise Room - Gym Equipment	2017	as needed	25000.00	25000.00	0	10
Exercise Room - Gym Flooring Replacement	2017	1 unit	1000.00	1000.00	0	10
Exercise Room - Gym Mini-Splits Replacement - 2 Ton Unit	2024	1 unit	1000.00	1000.00	7	8
Exercise Room - Gym TV Replacement (Done 2016)	2021	1 unit	750.00	750.00	4	5

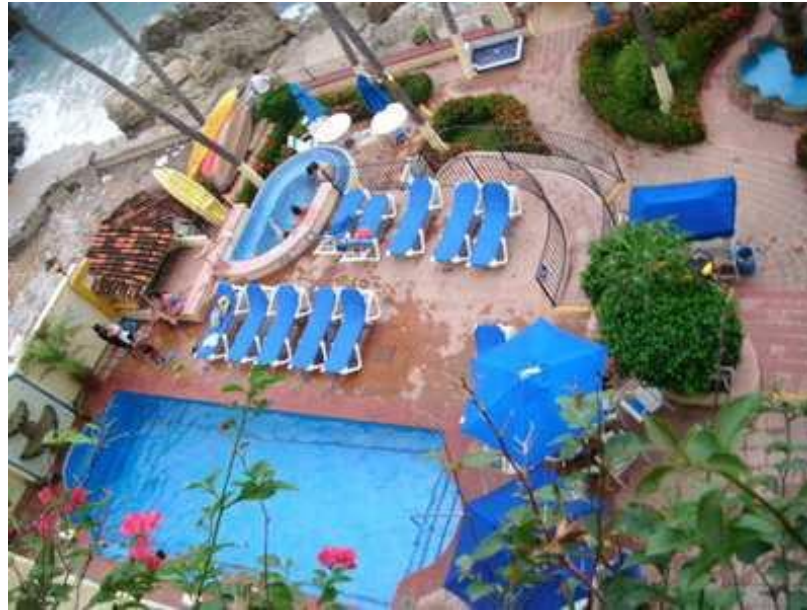
Component	Year Scheduled	Units	Cost Per Unit	Today's Cost	Estimated Remaining Useful Life (Years)	Estimated Life When New (Years)
Pool Area - Jacuzzi Filter	2022	3 units	800.00/unit	2400.00	5	7
Pool Area - Jacuzzi Filter	2022	1 unit	800.00	800.00	5	7
Pool Area - Jacuzzi Heater (Done 2016)	2023	ea	4000.00	12000.00	6	7
Pool Area - Jacuzzi Pump	2022	ea	1000.00	3000.00	5	7
Pool Area - Jacuzzi Resurface	2026	3 units	1200.00/unit	3600.00	9	12
Pool Area - Pool Filter	2020	ea	800.00	800.00	3	5
Pool Area - Pool Furniture	2022	all	3000.00	3000.00	5	10
Pool Area - Pool Heater	2022	1 unit	4000.00	4000.00	5	10
Pool Area - Pool Pump	2020	1 unit	500.00	500.00	3	5

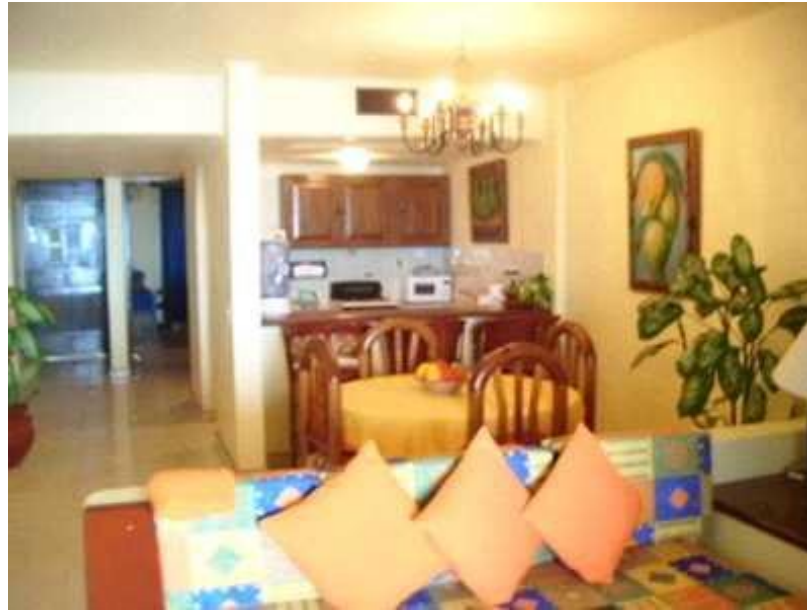
Component	Year Scheduled	Units	Cost Per Unit	Today's Cost	Estimated Remaining Useful Life (Years)	Estimated Life When New (Years)
Units - All Mattresses Replacement Phase 01 (Future)	2026	20 units	500.00/unit	10000.00	9	5
Units - All Mattresses Replacement Phase 02 (Future)	2027	19 units	500.00/unit	9500.00	10	5
Units - All Mattresses Replacement Phase 03 (Future)	2028	19 units	500.00/unit	9500.00	11	5
Units - All Remodel - Phase 01	2018	15 units	20000.00/unit	300000.00	1	30
Units - All Remodel - Phase 02	2019	15 units	20000.00/unit	300000.00	2	30
Units - All Remodel - Phase 03	2020	15 units	20000.00/unit	300000.00	3	30
Units - All Remodel - Phase 04 (103)	2045	1 unit	20000.00	20000.00	28	30
Units - All Window Coverings, Sofa Cushions, Bedding Remodel (Future)	2027	56 units	1500.00/unit	84000.00	10	10
Units - Furniture Contingency (Future)	Annual	as needed	12000.00	12000.00	5	1
Units - Kitchen Appliance Contingency (Future)	Annual	as needed	3000.00	3000.00	4	1
