Lindo Mar Resort

Full Reserve Study

Prepared for Year: 01/01/2026 - 12/31/2026

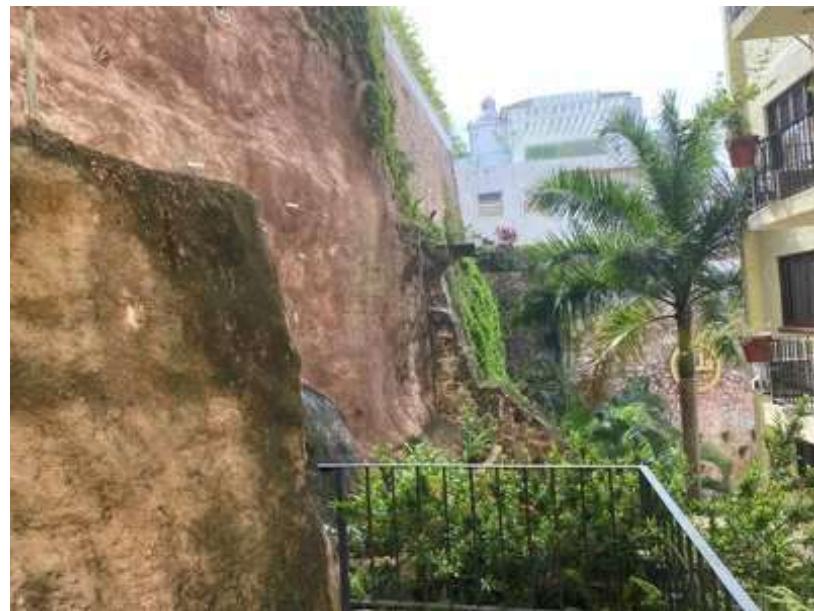
Renovation and repairs of the low side wall is scheduled to be done every year as needed. Further evaluation by a licensed contractor or engineer is recommended.

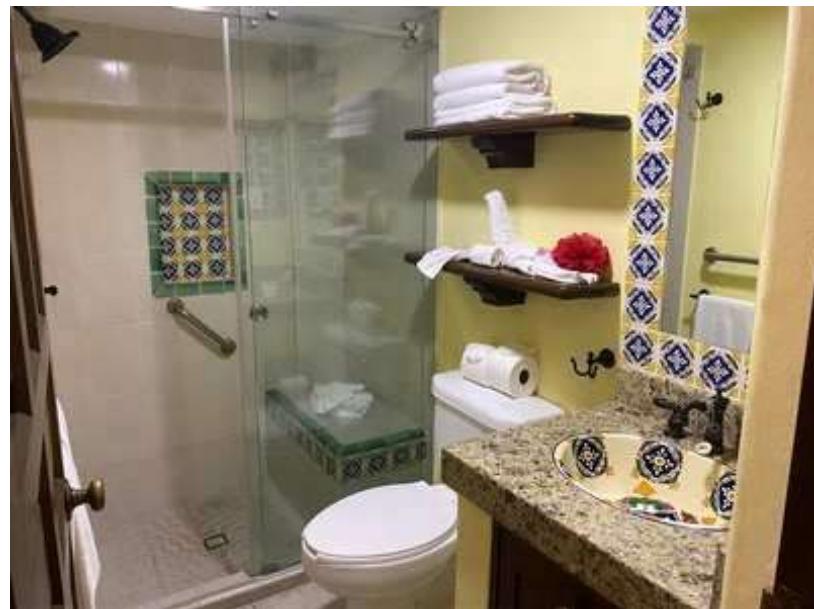
The Bathroom Remodel is completed when the units are remodeled. This includes the Tile Shower Enclosure, Cabinets, Counter Tops, Fixtures, etc. Remodels are scheduled to be done every 30 years.

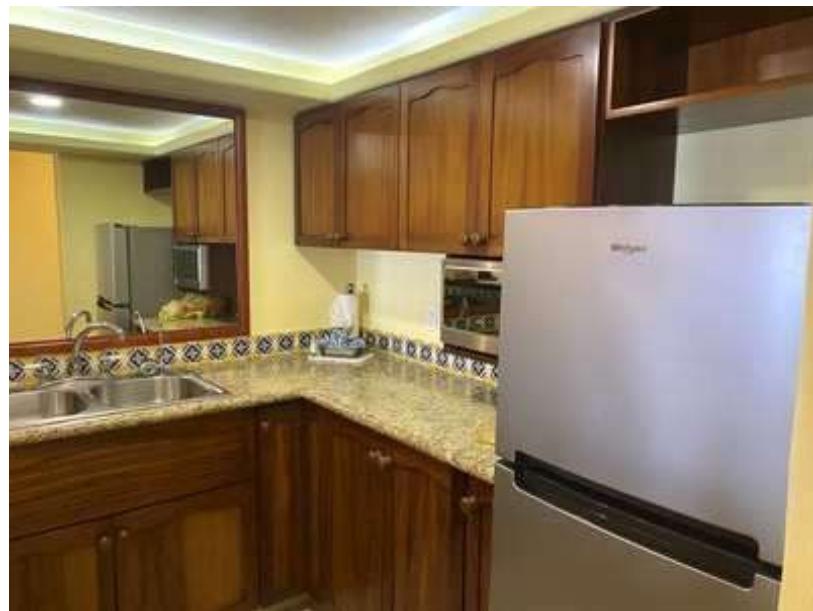
The Kitchens were remodeled when the units interior remodel took place. Appliances are replaced each year as needed through an allowance.

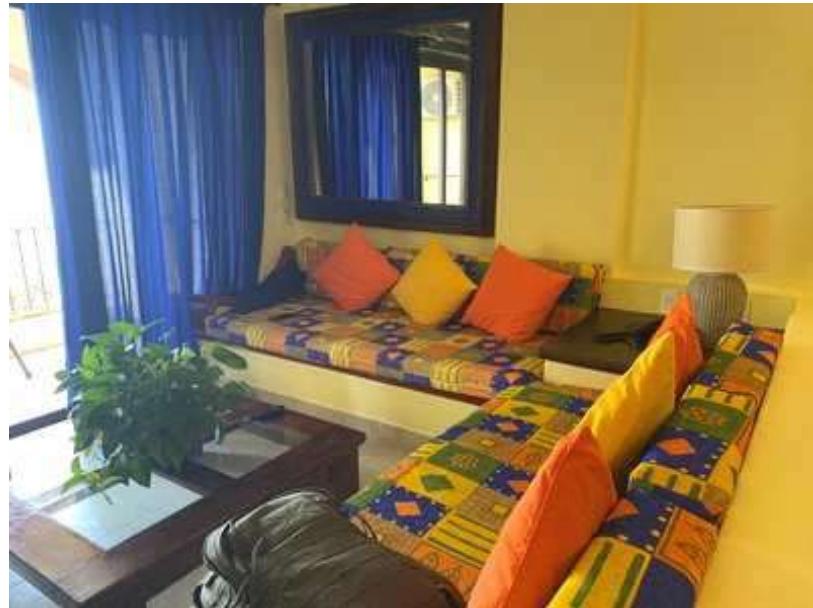
Painting of the interior of the units is done as needed by the resort staff. This cost is considered an operating expense and has not been included in the Reserve Study. Complete repainting is done when the units are remodeled.

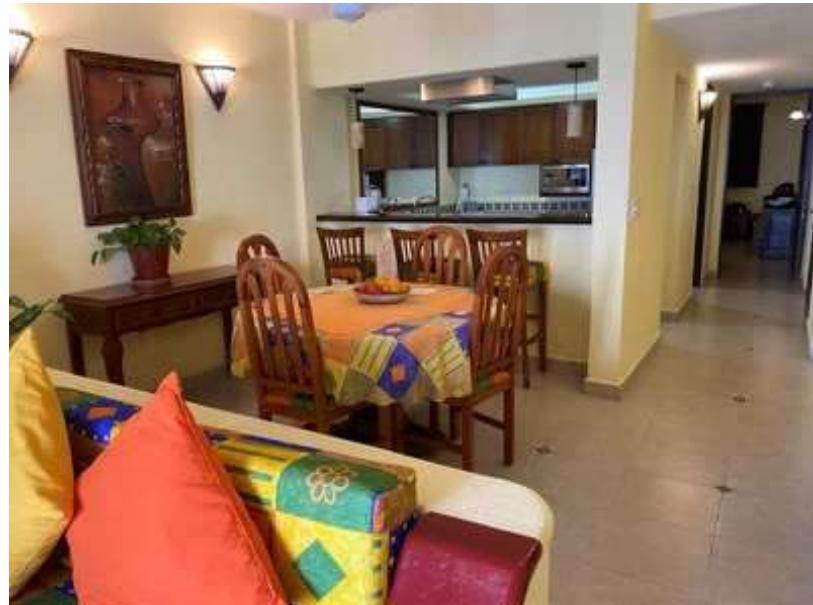
Furniture replacement is done as needed. Complete replacement of all furniture has not been scheduled until the future remodel is completed.

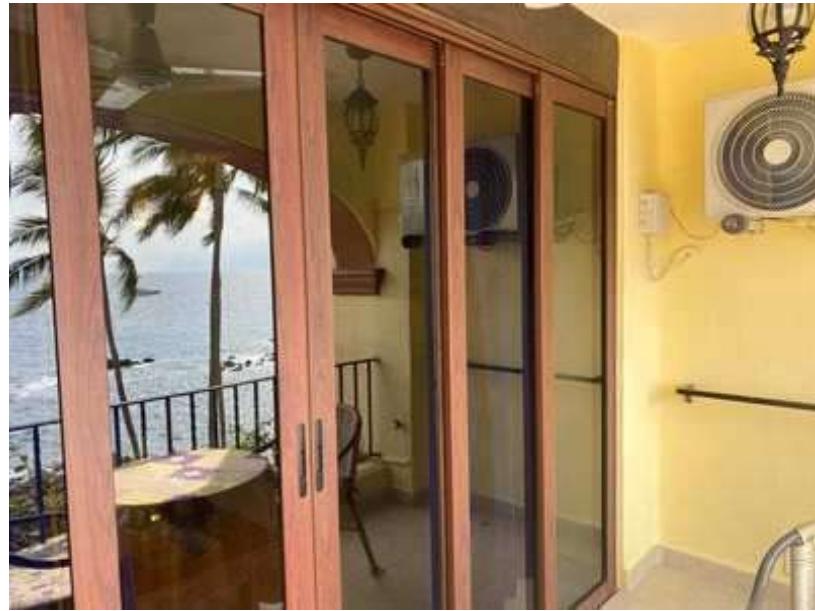
The Patio Doors were replaced when the units were remodeled. The estimated useful life when new is 20 years.

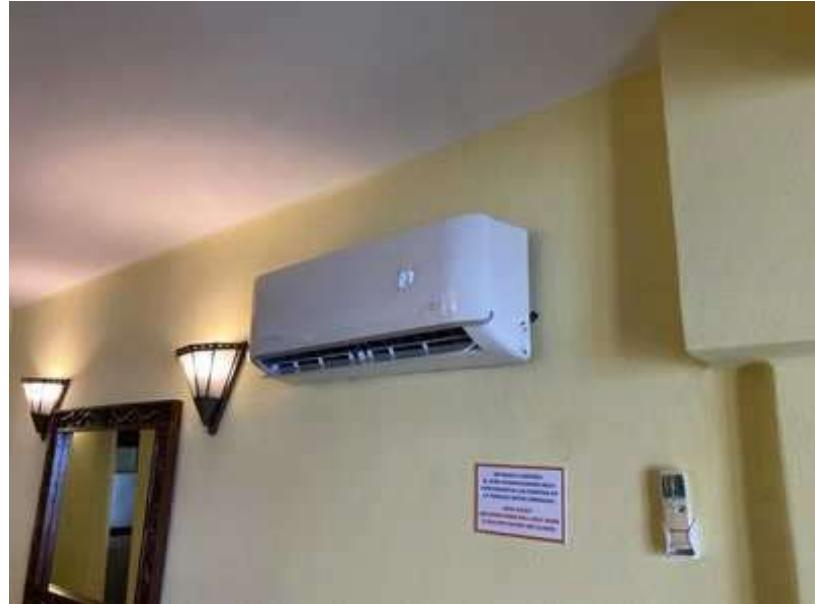
Complete replacement of all Mini Split Units has not been scheduled. Instead, an annual allowance for replacement has been included in the reserve study.

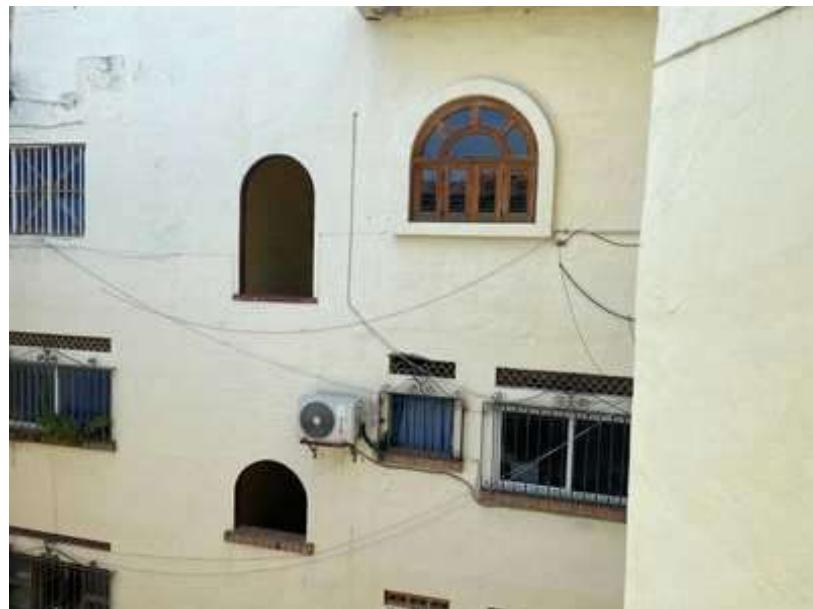
Replacement of the broken employee windows has been included in the reserve study to be done as needed.

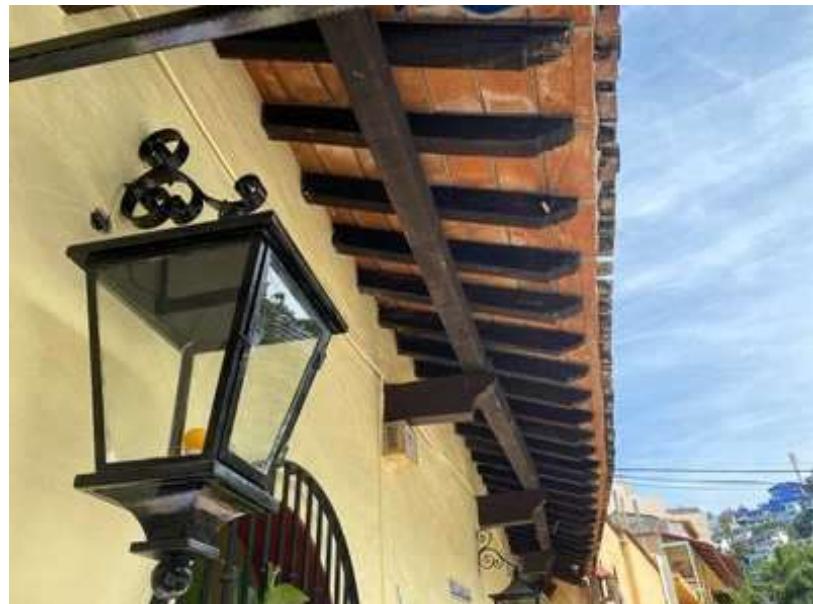
Replacement of the wooden beams with metal beams has been included in the reserve study. This is considered a one-time expense.

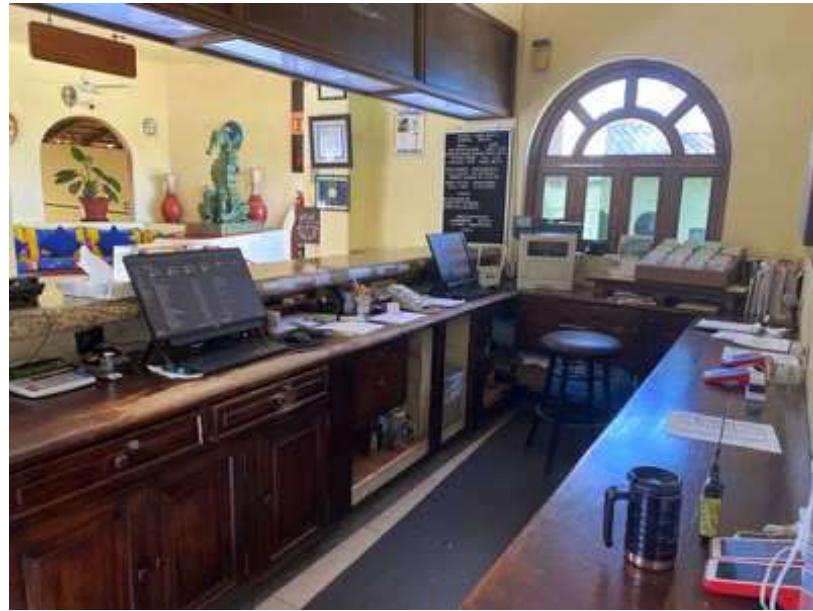
The Lobby Renovation includes the front desk computer equipment, font desk renovation, flooring, and painting.

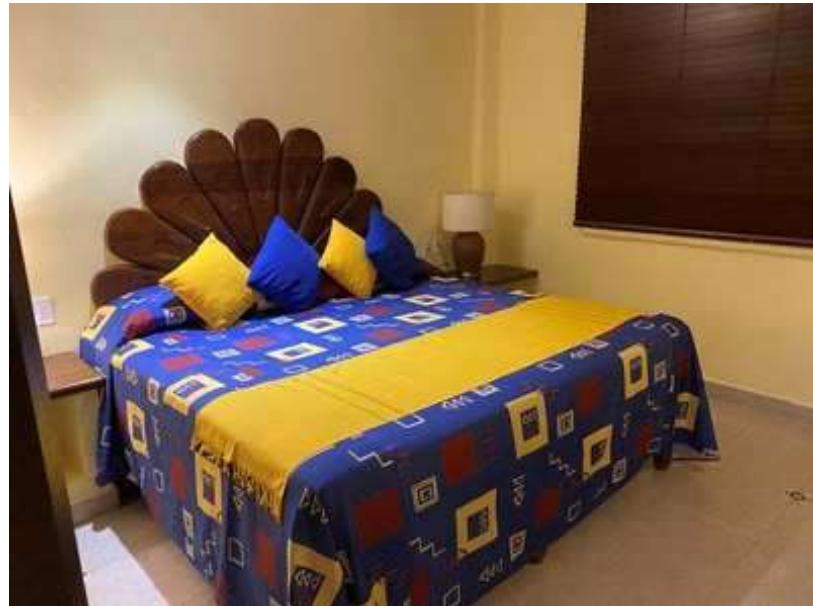
The Bedspreads, Pillow and Cushion Covers and Window Coverings are scheduled to be replaced every 5 years, as needed. Mattresses are replaced each year through an allowance.

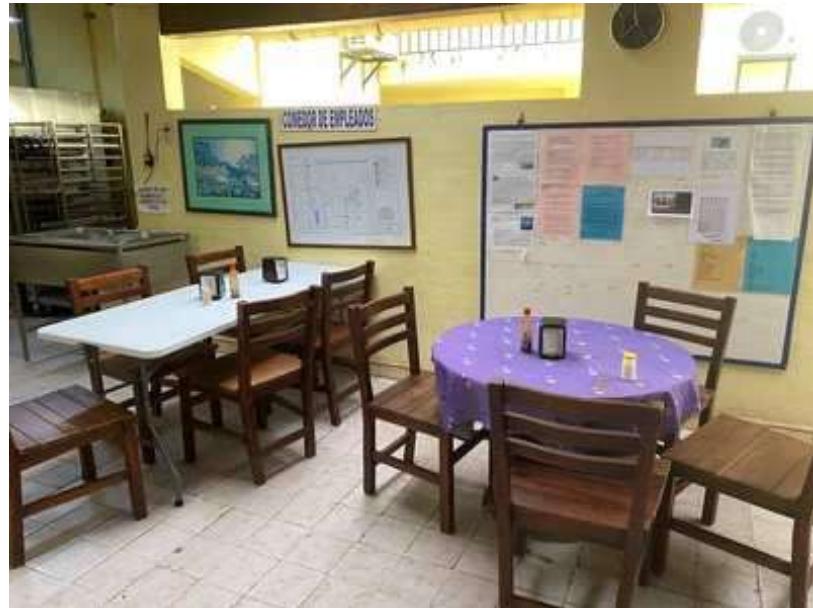
Renovation of the employee break room, bakery and butcher area has been included in the reserve study.

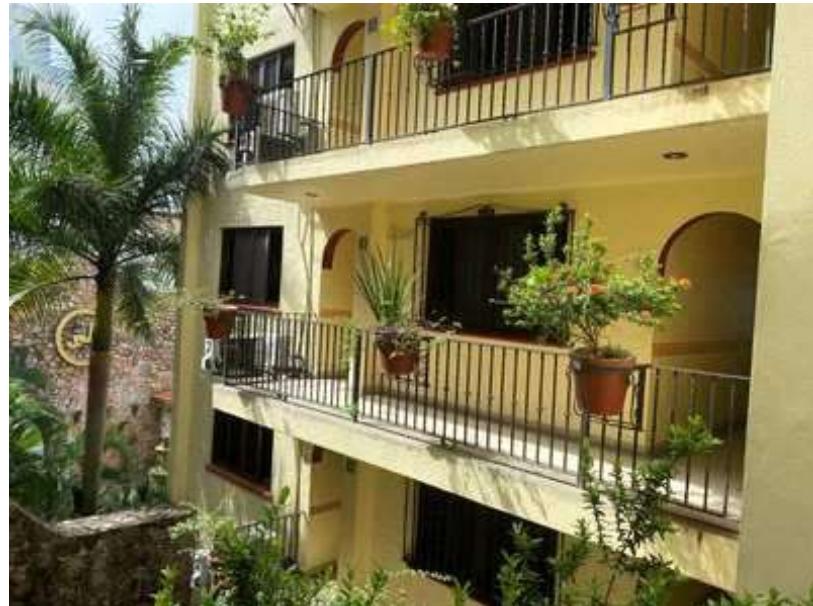
Exterior Building Painting is scheduled to be done every 10 years. The cost and useful life is an estimation only.

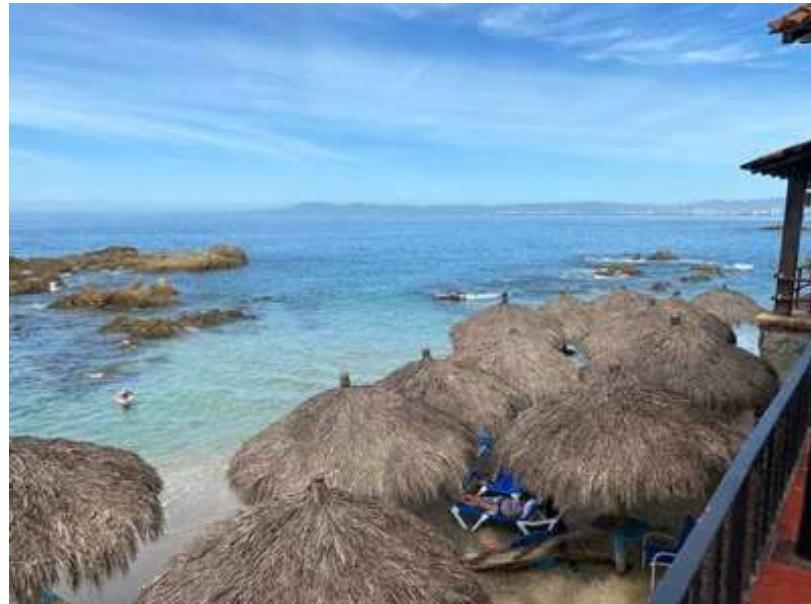
Replacement of the Palapas is scheduled to be done every year, as needed through an allowance. Full replacement has not been scheduled.

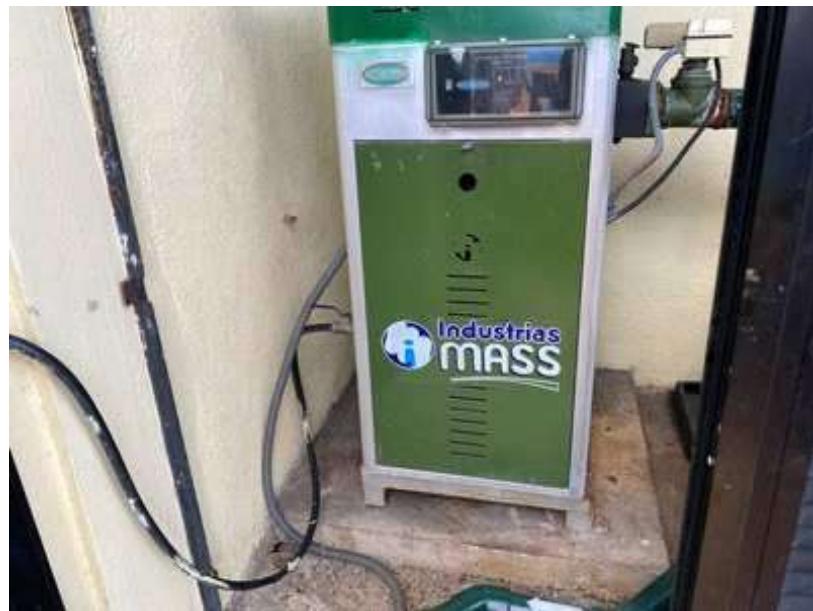
All Pool and Spa Equipment replacement has been listed in the Reserve Study. Costs and useful lives were provided by the resort manager.

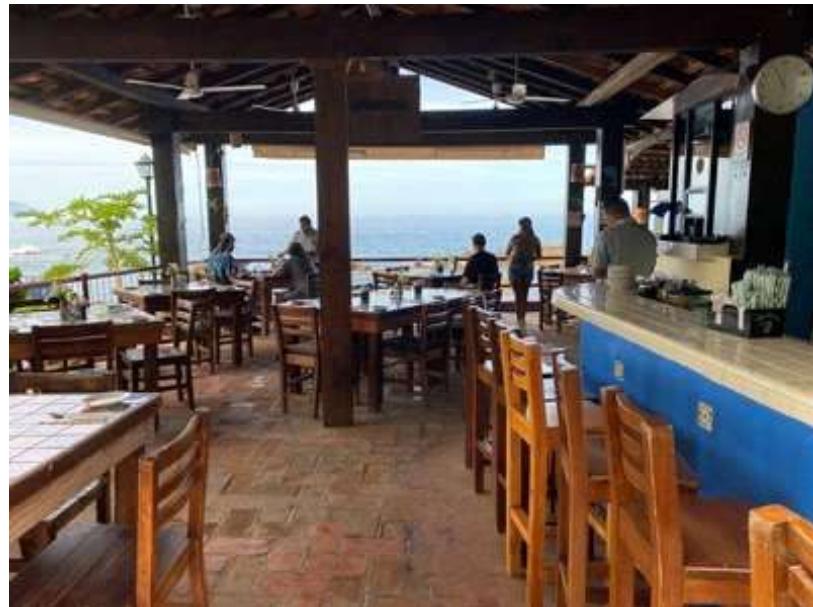
Renovation of the restaurant on the "bar side" has been included in the Reserve Study. Complete remodel of the entire restaurant has not been scheduled.

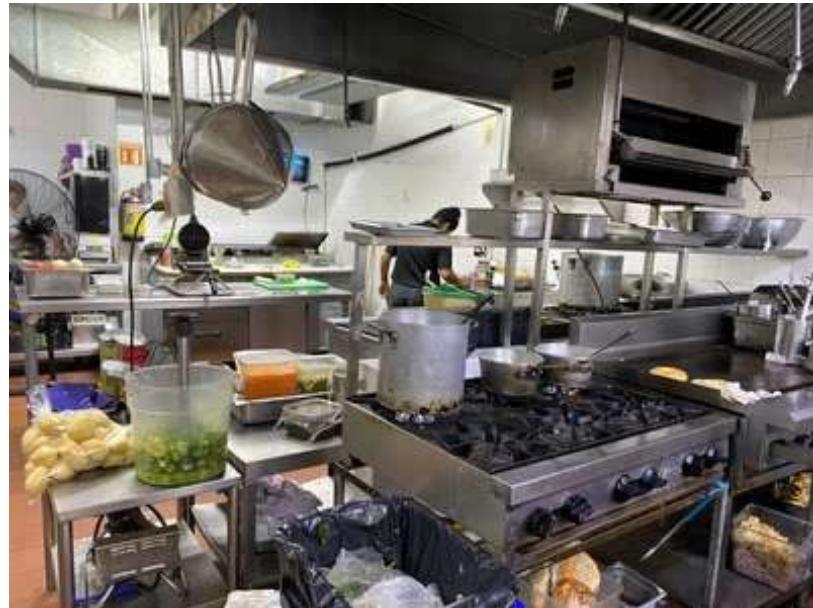
Complete replacement of all restaurant equipment has not been scheduled. Instead, an allowance for replacement has been included in the reserve study so that equipment may be replaced as needed.

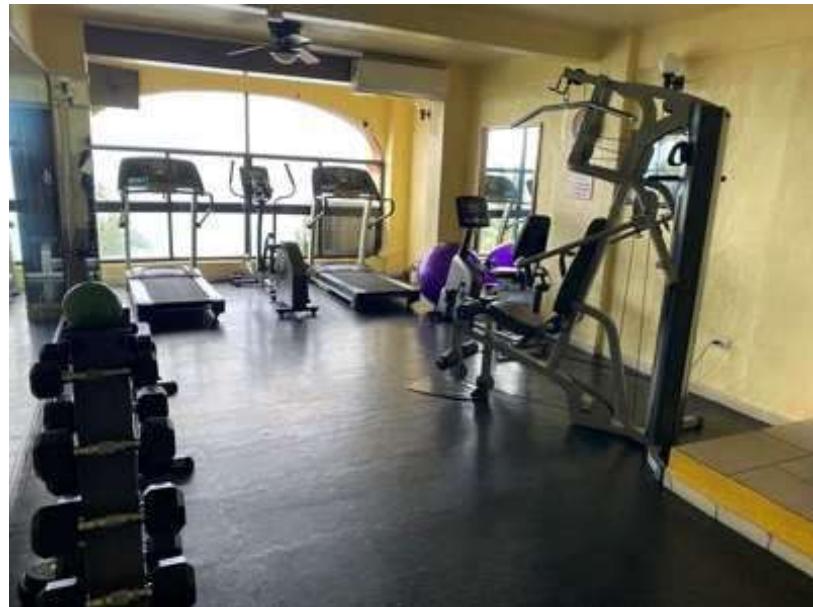
Replacement of the exercise equipment has been scheduled to be done. The costs are based on actual costs provided by the resort manager.

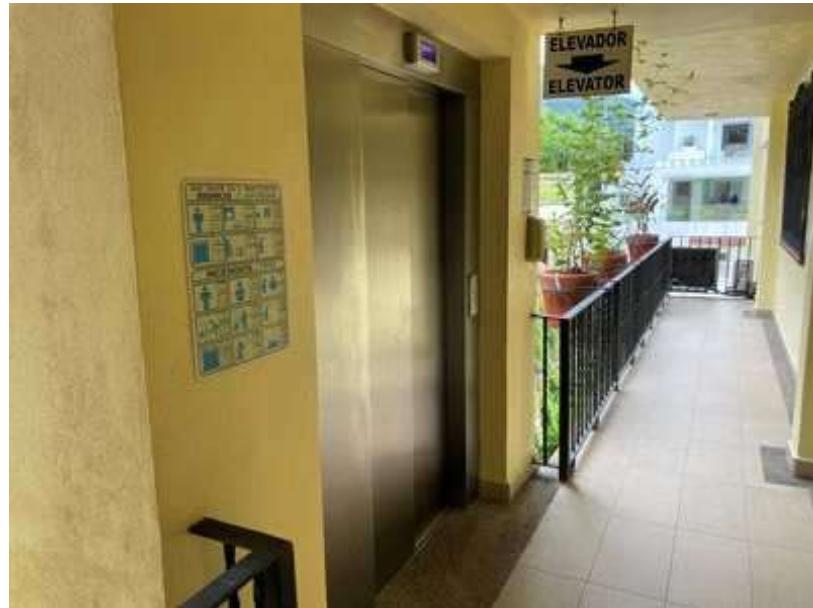
The elevator modernization and major repairs have been included in the reserve study. The prices are based on actual costs provided by the resort manager.

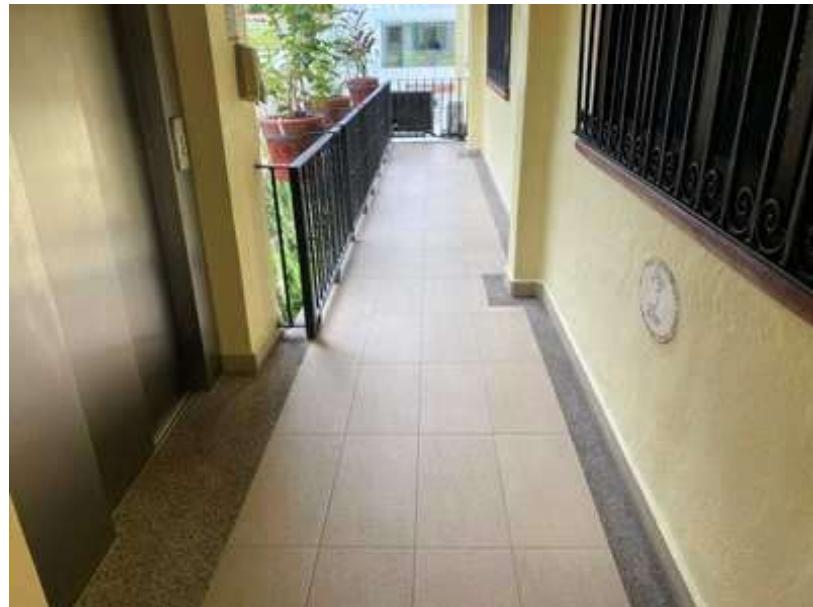
The Walkway Tile was replaced when each floor was renovated. Tile replacement has not been listed separately in the reserve study.

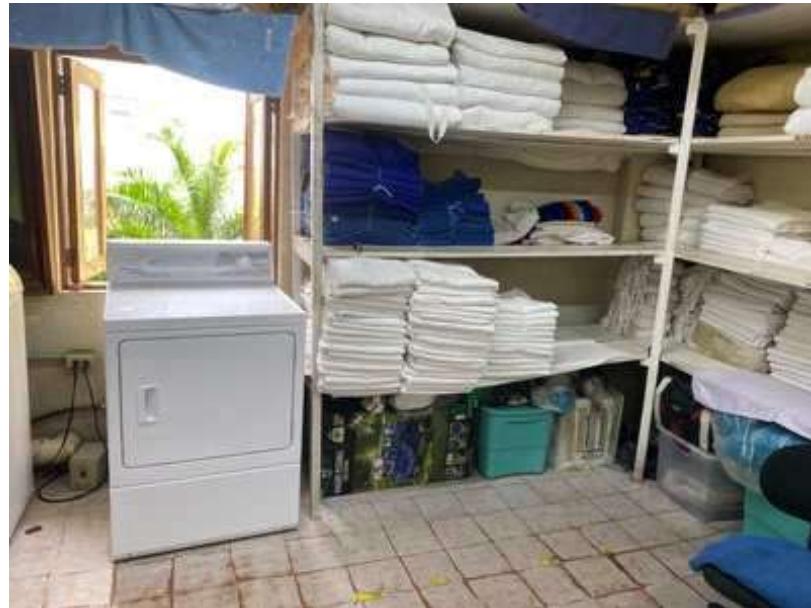
Replacement of the commercial washers and dryers is scheduled to be done every 5 years. Linens, bedding and towels are replaced through the operating budget.

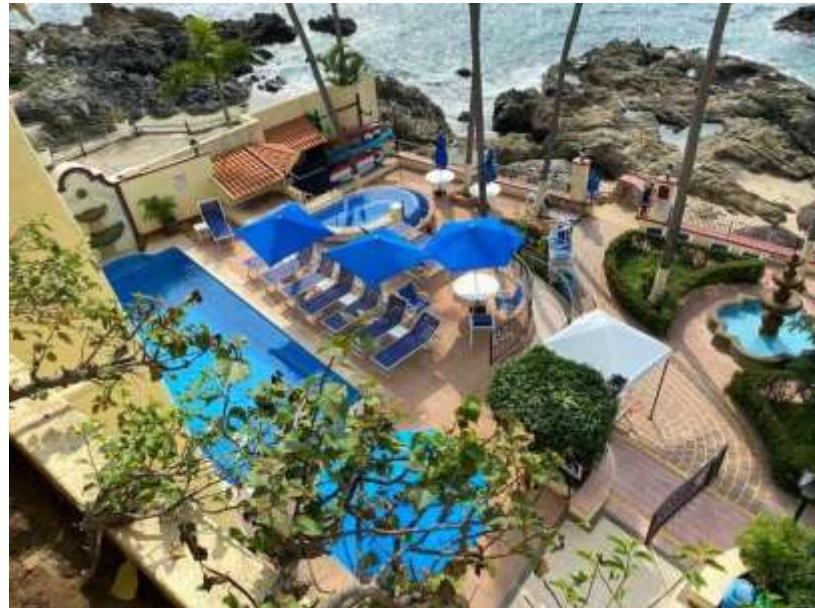
The Lindo Mar Resort is very well maintained and in good overall condition.
